## **Flow Slides: Understanding their geo-mechanical mechanisms, the threats they pose and how these threats can be managed**

Konrad Beinssen<sup>1</sup>, Dick R. Mastbergen<sup>2</sup>

### **Abstract**

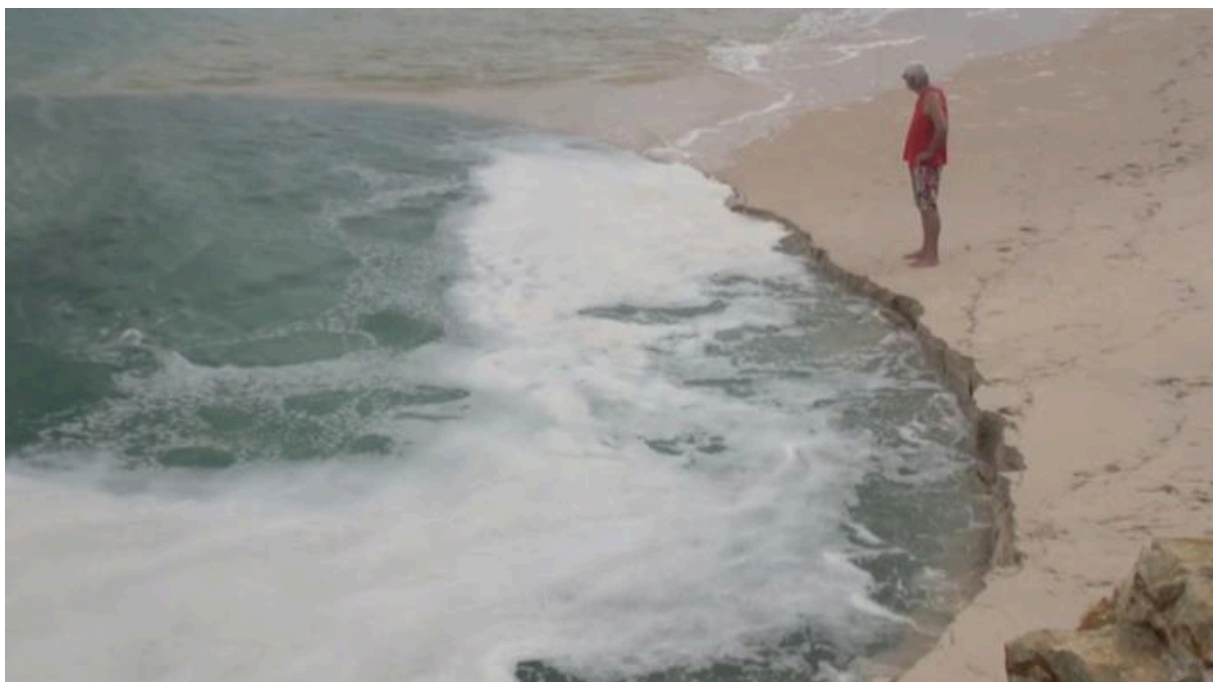
**Figure 1.** This image shows an active retrogressive breach failure (RBF) event at Amity Point, advancing at about 0.8 metres per minute. The spectator is standing on top of a 7 metre high, near vertical subaqueous wall of sand (the breach) which is sustained by a temporary strain hardening of the sand skeleton immediately behind the breach (under the observer's feet).

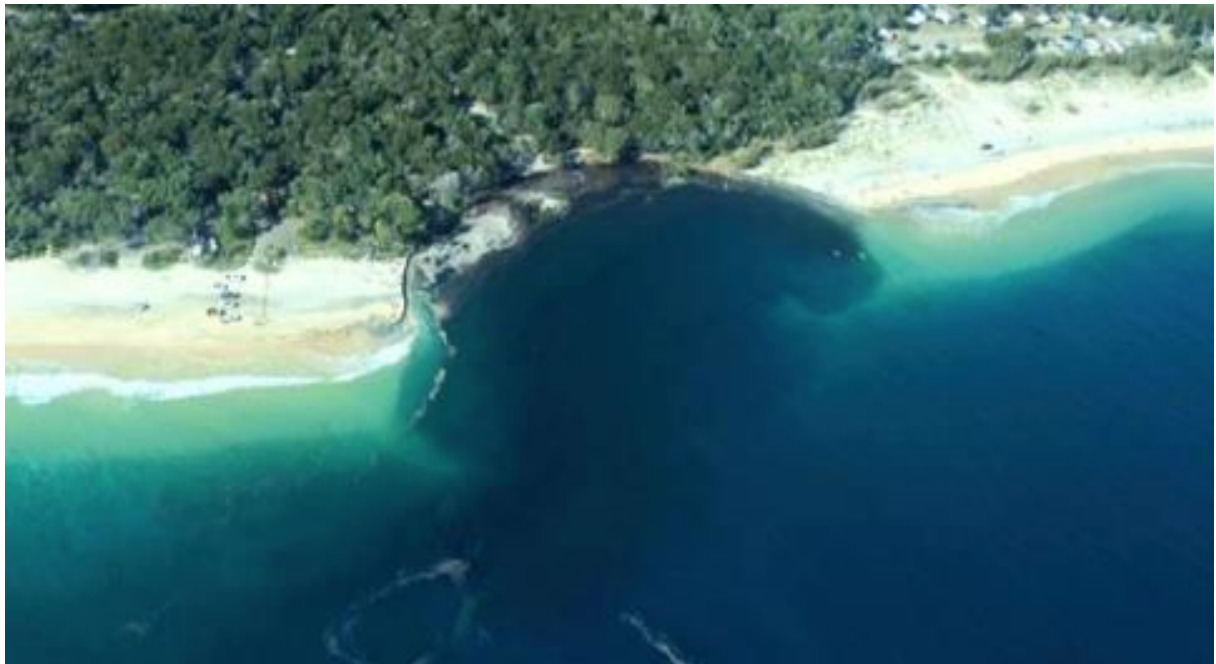
At Inskip Point in Queensland, a large RBF event occurred on 26/9/2015 and impacted a camping area at about midnight (Figure 2). Many similar events have occurred along this stretch of beach, posing a risk to campers and beach traffic, particularly at night. Shipway (2015) describes the problem and recommends risk management measures.

**Figure 2. This image shows the amphitheatre shaped crater left after a large RBF event at Inskip Point, Queensland which took place at night on 26<sup>th</sup> September 2015. This event retrogressed into a camping area behind the beach and undermined a car and caravan. Many similar events have occurred on this beach.**

At Inskip Point in Australia, camping has been prohibited in vulnerable areas close to the beach and beach driving has been restricted in areas known to be flow slide prone (Shipway 2015). The building of hard structures at this site cannot be justified.

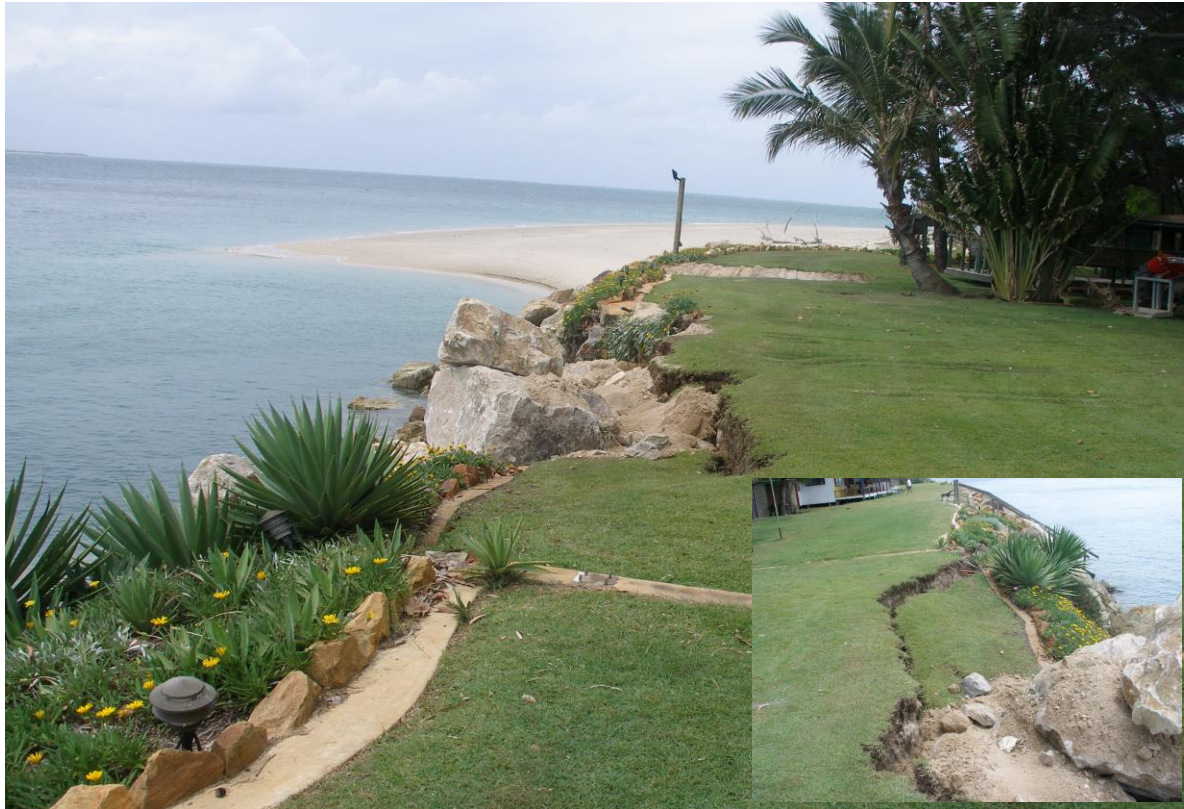
At Amity Point in Queensland (Figure 3), many RBF events have occurred dating back over a century. Coastal recession here has been consistent and significant over many years but its RBF mechanism has only recently been recognised (Beinssen, Neil and Mastbergen 2014).

**Figure 3.** These images show a slump in the riprap 'flow slide barrier' at Amity Point in Queensland after it had been undermined by an RBF event. Repairs by adding new rock have started. The amphitheatre shaped crater in the beach left after the termination of this event can be seen in the background.

At Amity Point, the village is protected by a progressively built rock wall recently named a 'flow slide barrier' (Figure 3). This structure has proven to be successful in arresting coastal recession. Whilst it has been undermined on many occasions by RBF events which penetrate under its foundations, it is repaired by adding rock to the top and in this way has become progressively more stable over time (Beinssen and Neil 2015). The Dutch experience of groynes being ineffective has been mirrored at Amity Point where an earlier built groyne field did not provide a solution to the flow slide threat.

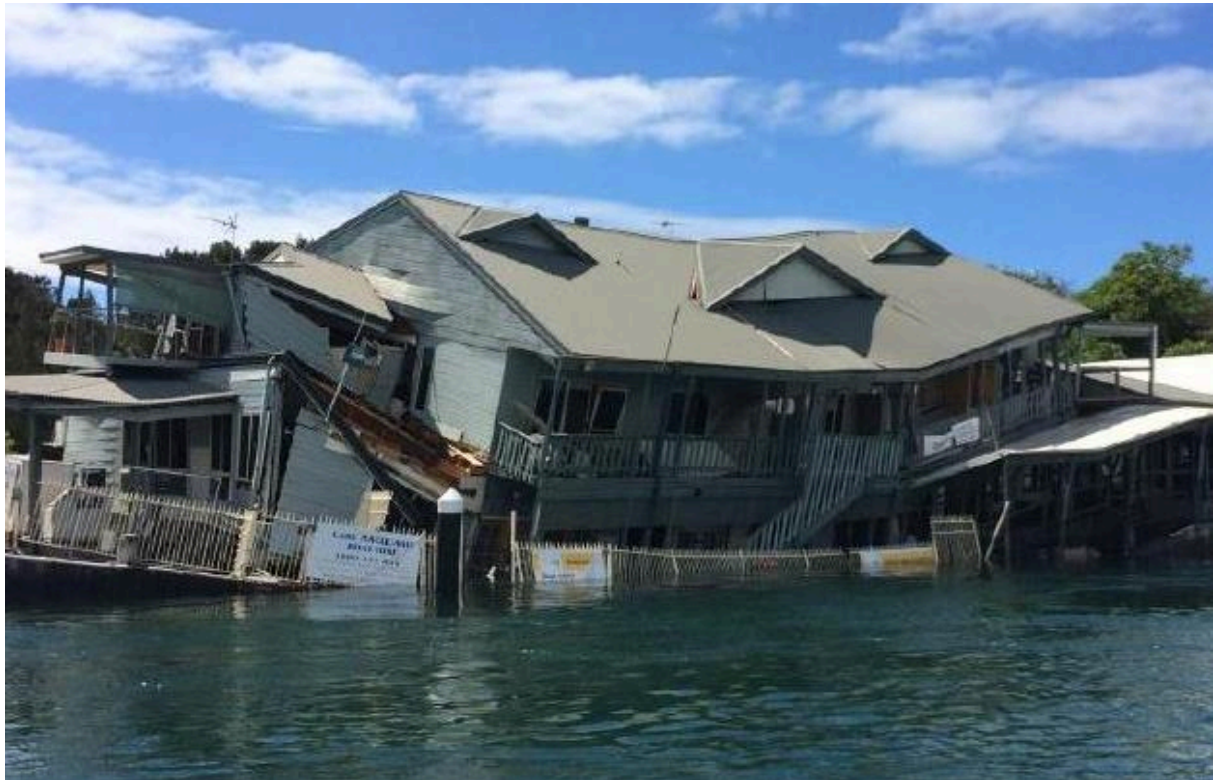
At Pelican in NSW, a building unexpectedly and suddenly collapsed during calm conditions at 9.45am on 8/2/2016 (Figure 4). The building was built partly over the water and supported on its seaward side by piles driven into fine subaqueous sand. The sudden nature of the collapse of this building (which

had been recently declared structurally sound) fits with the hypothesis that the outer piles were undermined by an RBF event.

**Figure 4** This building at Pelican on the mid north coast of NSW collapsed at 9.45am on 8/2/2016 during calm conditions. It was supported by piles driven into the subaqueous sand at the building's seaward side. Undermining of these piles by an RBF event could explain this sudden collapse.

Finally, if the building collapse at Pelican in NSW was caused by an RBF event that undermined its outer piles, then these piles driven deeper and preferably to bed rock, would have saved the building (Figure 4).
