# **RABY BAY CANAL BATTER STABILITY UPDATE**

## **Geotechnical Investigation Analysis Report**

**REDLAND CITY COUNCIL**

BEJ809.002-W-REP-003 Rev. 0

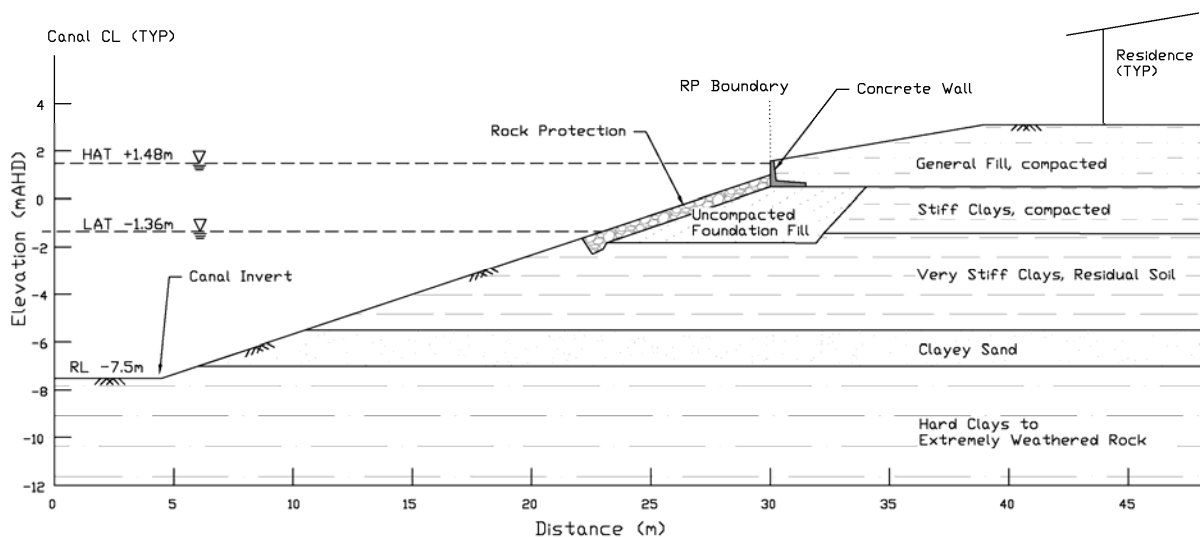
**Figure 2.1**  
**SIMPLIFIED SOIL PROFILE LAYOUT**

- the author’s interpretation of the geotechnical data is the observed slope failures are largely confined to this uncompacted ‘foundation fill’ wedge, thus the slips appear to be shallow and short in length.

Figure 2.1 is based on construction drawings, Soil Surveys report and KBR interpretation. An A3 copy of this diagram is included in Appendix C.

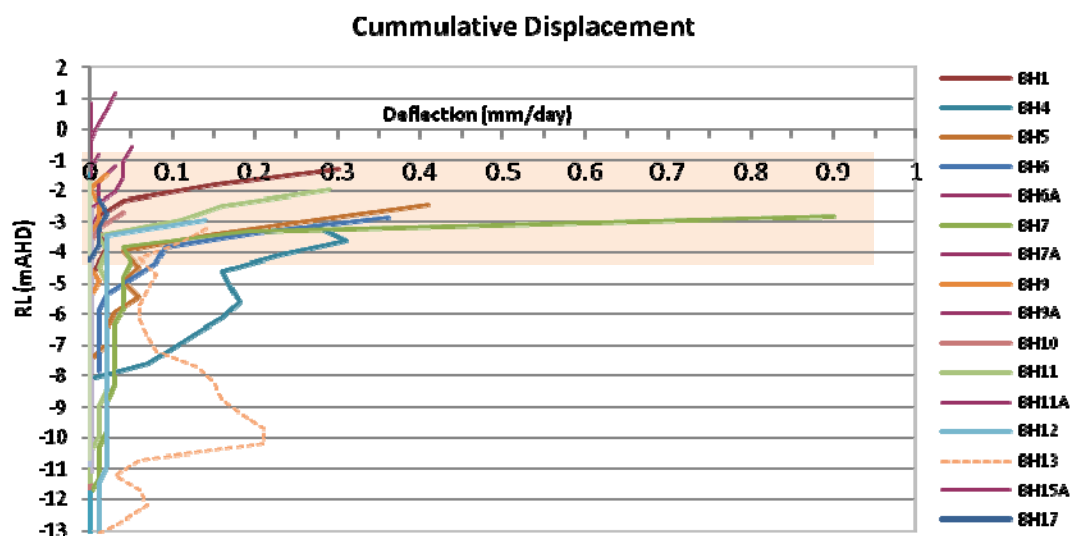
Figure 2.2  
BOREHOLE DISPLACEMENT RECORDS

This information suggests that the soil slip is occurring in a shallow zone underneath the rock protection and concrete wall. As the soil begins to move in these higher layers, the movement stresses the lower soil layers which result in the small displacements observed here. Figure 2.2 and 2.3 show the displacement records from the boreholes demonstrating this pattern of soil movement.

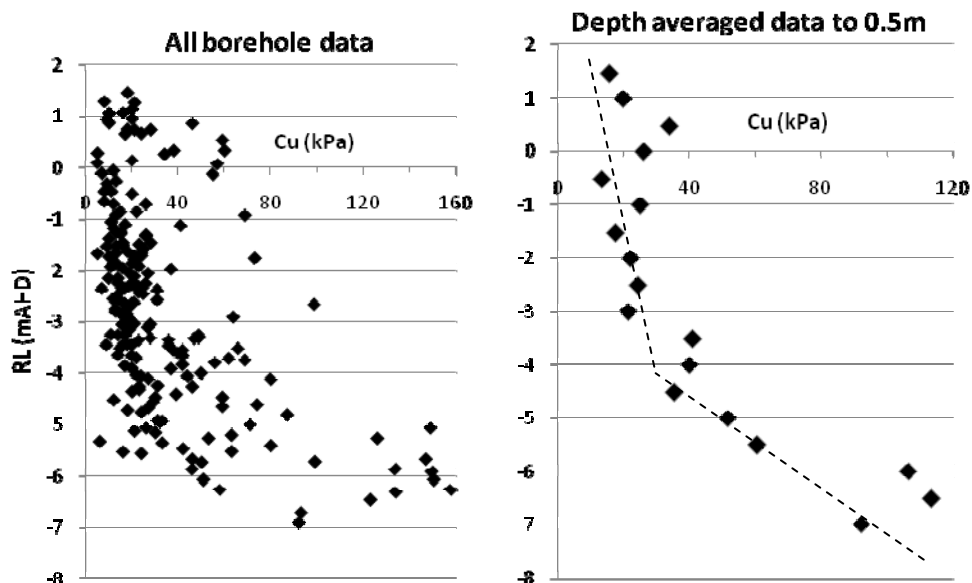
**Figure 2.4**  
**UNDRAINED SHEAR STRENGTH MEASUREMENTS FROM DILATOMETER TESTS**

Soil density, pore water pressures, cohesion and friction angle values are the main properties that affect slope stability. Figure 2.4 shows two plots of undrained cohesion values  $c_u$  with respect to depth. The first plot includes all data from the dilatometer tests, while the second shows these values averaged over 0.5 m bins. It is important to note that there is a significant increase in average recorded shear strength at approximately  $-4.0$  mAHD. This is consistent with the typical level where lateral displacement is first observed in the borehole displacement records in Figure 2.2. It is inferred that this is near the level where very stiff clay was encountered after soft overlying material was removed during construction.

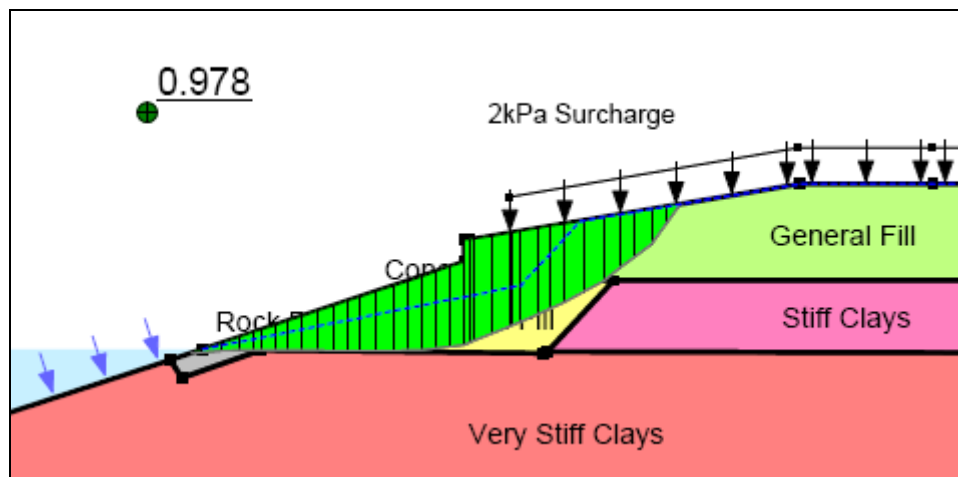
**Figure 3.2**  
**CRITICAL SLOPE FAILURE – FOS  $\approx$  1.0**

The critical slip surface is shown in Figure 3.2. The authors believe that the model result is consistent with the surface observation of slope failures in Raby Bay; a shallow slip surface through the weak wedge of uncompacted fill behind the rock protection. Borehole data indicates lower shear strength in this region. A hypothetical deep slip failure mode doesn't appear to be critical, nor has it been observed in the field by the writers.

| Case | FOS | Figure | Type of failure |
|---|---|---|---|
| Critical slip failure for approximated current slope | 0.978 | 3.2 | Shallow slip failure through fill material |

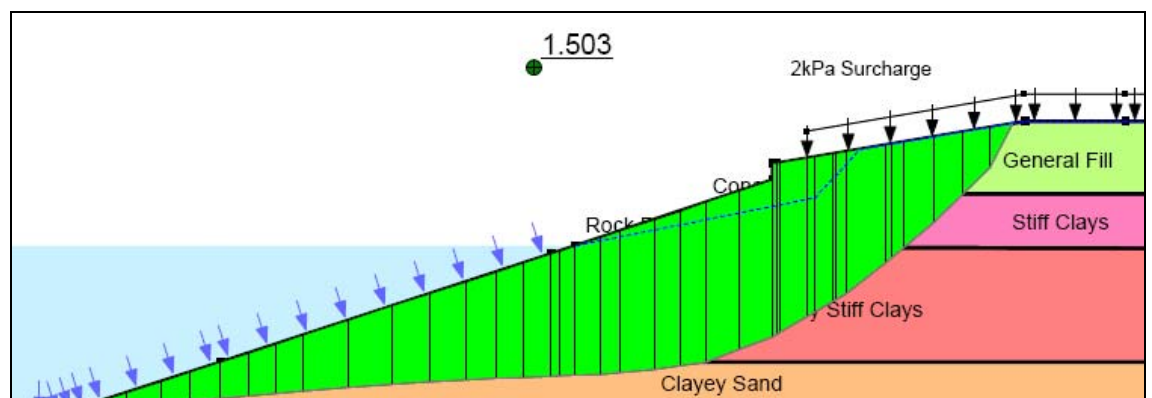
**Figure 3.3**  
**CHECK OF DEEP SLIP FAILURE – FOS  $>$  1.5**

| Case | FOS | Figure | Type of failure |
|---|---|---|---|
| Check for deep slip failure | 1.503 | 3.3 | Deep slip through toe of slope |

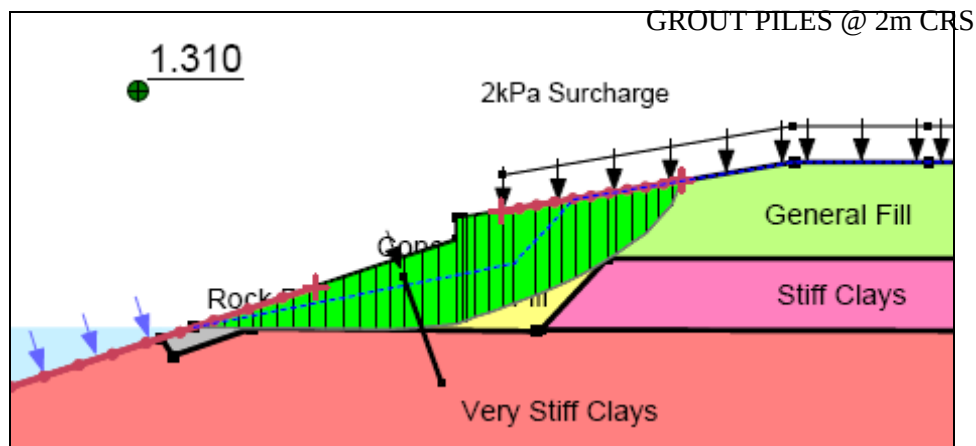
**Figure 3.4**  
**GROUTED PILES INCLUDED (A) – FOS < 1.5**

| Case | FOS | Figure | Type of failure |
|---|---|---|---|
| 3 m grout piles at 2 m spacing (0 mAHD) | 1.310 | 3.4 | Shallow slip failure through piles in fill material |

A plausible low cost method of stabilizing a shallow slip is the installation of grout-injected piles into the soil behind the rock protection. Figure 3.4, 3.5 and 3.6 show the Slope/W model with the addition of 0.6 m diameter piles at varying spacings, to a depth of 3 m to test the impact to slope stability.
