# Coochiemudlo Island Shoreline Erosion Management Plan: Stage 2 - Shoreline Erosion Management Study

Reference: R.B23255.001.03  
Date: February 2020  
Confidential

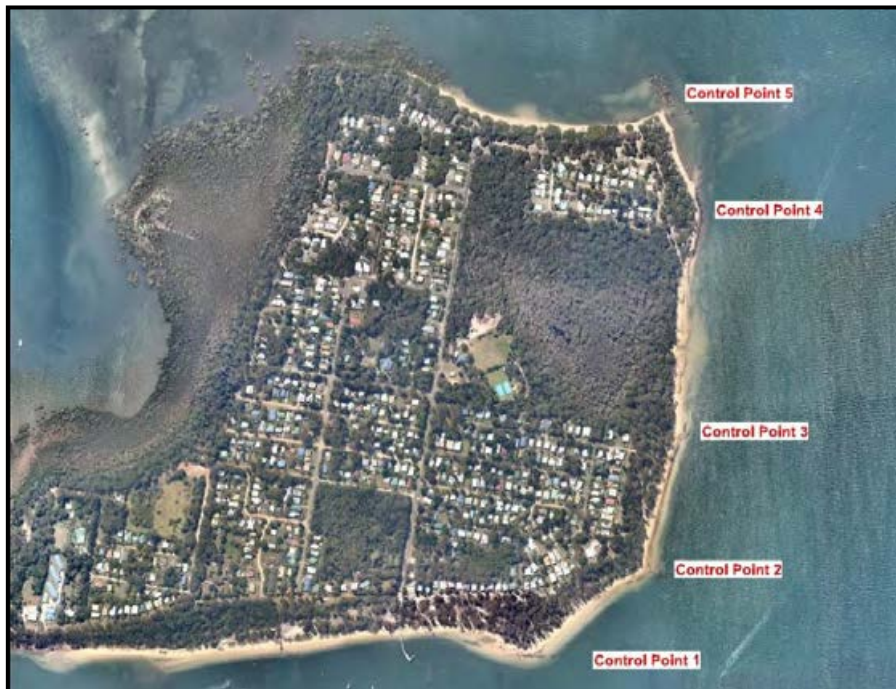
Figure 3-3 Control points for beach alignment (BMT WBM 2015)

The Norfolk Beach Shoreline Erosion Study (BMT WBM 2015) identified five rocky reefs/headlands on the eastern side of the island that control beach alignment, as shown in Figure 3-3. Sand movement along the shoreline is influenced by the degree of exposure of the rocky reefs/headlands and may be significantly different at high tide compared to low tide.

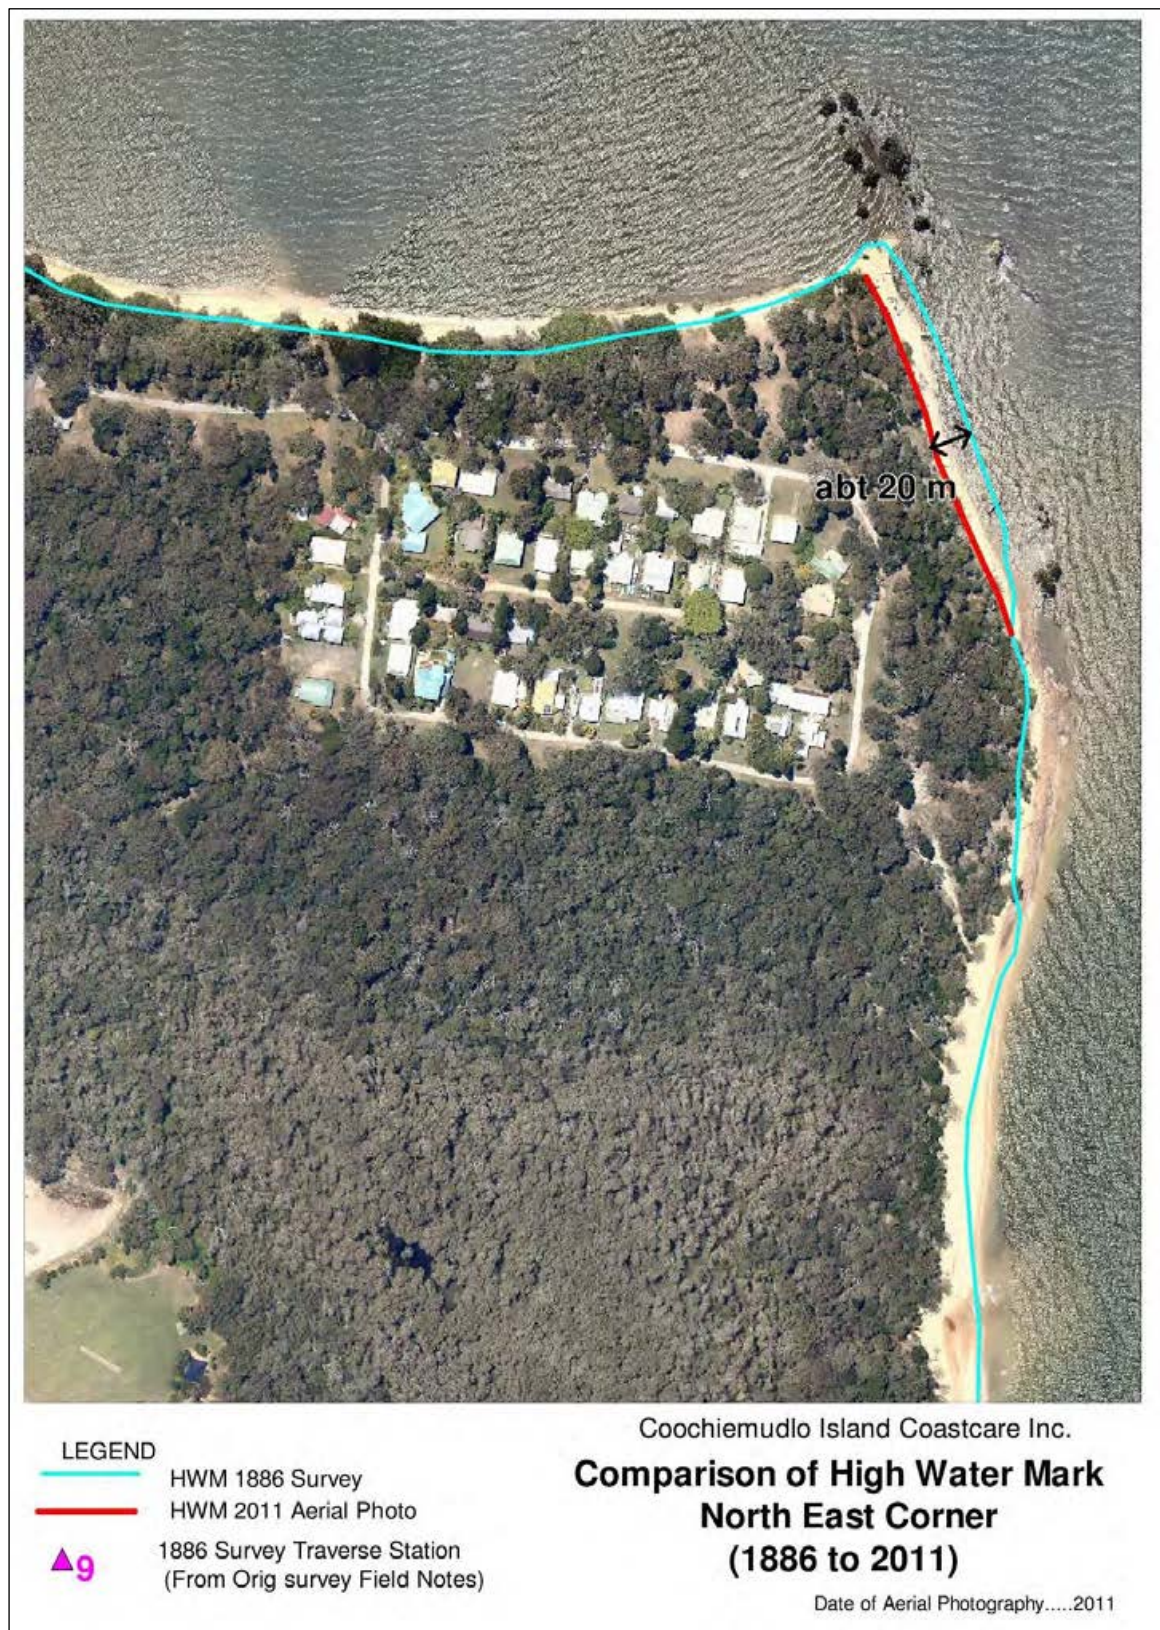
Figure 3-4 Comparison of the North East Corner High Water Mark (Provided by Coochiemudlo Island Coastcare and courtesy of Mr Keith Slack)

It is noted that an image has been shared by Coochiemudlo Island Coastcare (Figure 3-4) indicating erosion of approximately 20 m on the eastern beaches since the survey of the high water mark in 1886 and may indicate significant changes between 50 and 100 years ago. Subsequent information provided by Mr Keith Slack confirms that this map shows the original survey plan (C3281) showing the surveyed High Water Mark as defined by surveyor George McDonald in 1886, georeferenced with the Digital Cadastral Data Base and Nearmap photography dated October 2011. The oldest aerial photography available through the Queensland Governments online collection (<https://qimagery.information.qld.gov.au/>) is the 1955 imagery discussed above it is not possible to confirm the degree of change taking place prior to 1955. In any case future management options should consider the recent changes as indicated below.

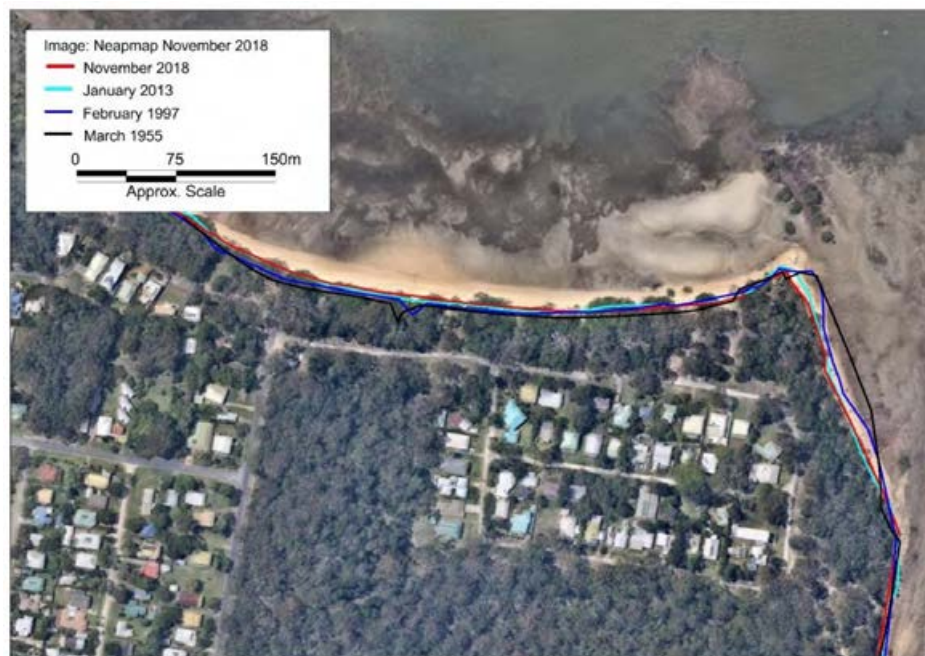
Figure 3-5 Morwong Beach and north-eastern Norfolk Beach

Consistent accretion of up to 14 m was observed along the majority of Morwong beach between 1955 and 2018. Aerial images show a build-up of sand on the intertidal area at the eastern end of the beach. It is likely that this sand has been eroded from north-eastern Norfolk Beach under south-easterly waves. Once on Morwong Beach it is progressively transported westward along the beach. A separate build-up of sand is visible across the inter-tidal area in the centre of the beach, close to a small ephemeral creek outlet that channels stormwater and drains the dune system following heavy rainfall. The proximity of this build-up close to the creek mouth indicates that the sand has been scoured from the upper beach by creek flows.

Aerial images from 1955 and 1997 show the rock outcrop (Control Point 5) connected to Morwong and Norfolk beaches by a sand spit forming a tombolo. Loss of vegetation on the rock outcrop and sand spit occurred between 1955 and 1997 with subsequent erosion of the connecting spit occurring between 1997 and 2013. Ongoing erosion has been observed on north-eastern Norfolk Beach (between Control Point 4 and Control Point 5 as shown in Figure 3-3), with aerial photography (refer Figure 3-5) indicating erosion of approximately 20 m since 1955. Minimal change in the vegetation line has occurred in the vicinity of Control Point 4 at the southern end of the beach segment.

Site inspections in October 2018 and March 2019 observed an exposed rocky substrate with patchy sand. A geotechnical investigation to determine the depth of the sand layer and extent and composition of the rocky substrate would be required to inform potential future erosion estimates.

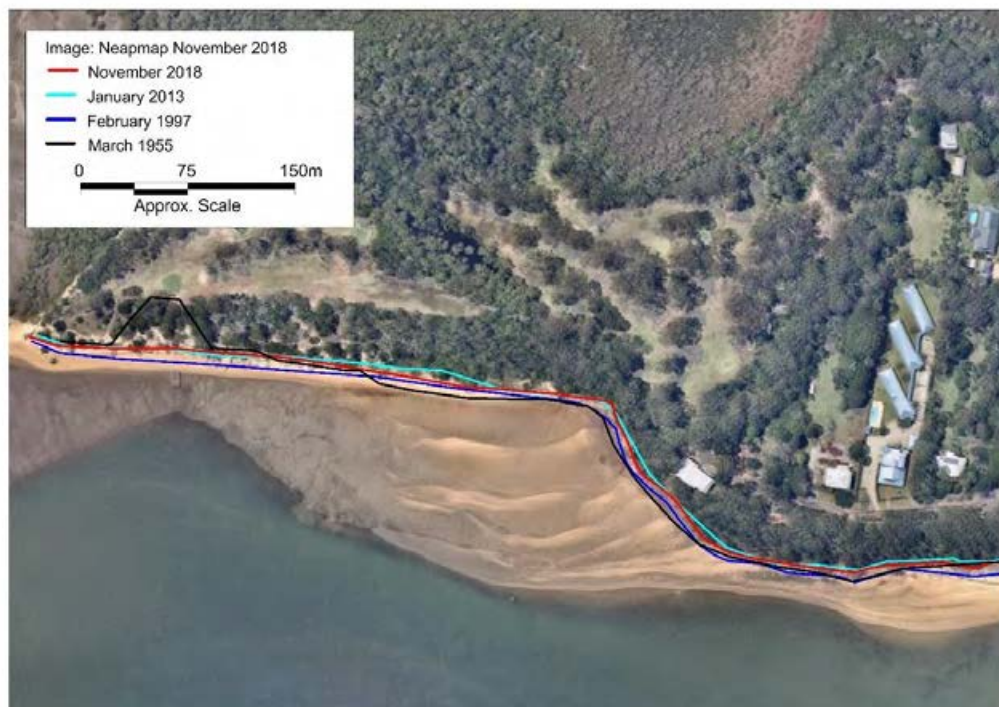
Figure 3-9 Main beach fronting the golf course and Red Cliffs

Comparison of the historical vegetation lines between 1997 and 2018 suggests erosion of the section of Main Beach fronting the golf course (Figure 3-9) of up to 10 m, most of which had occurred prior to 2013. However, along the central-eastern portion of the beach, the 2013 profile was much further landward than the 2018 image. Examination of imagery captured between these dates confirms gradual accretion of the beach in the interceding period, with the 1997 and 2018 shorelines being in generally similar positions.

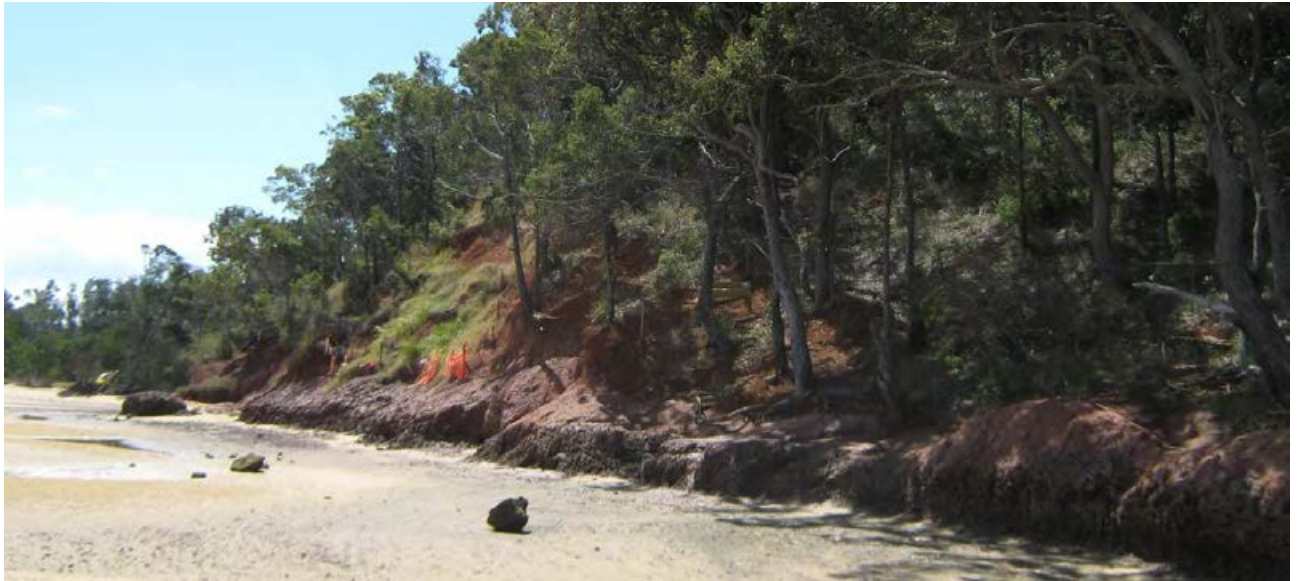
**Figure 3-10 Red Cliffs, BMT Site Inspection October 2018**

Erosion of the Red Rock cliff face was the subject of a geotechnical investigation in 2013 (Soil Surveys, 2013) which concluded that slumping of the cliff face due to terrestrial storm water flows was the primary cause of observed erosion.

- The failure process is to some degree cyclic. Vegetation takes root in the weaker zone binding it, the weakening continues into the face past the reinforcing effect of vegetation until conditions (eg a storm causes saturation) result in this outer layer slumping off.

- There is also a process where water at the base causes softening followed by undercutting at the base causing local over steepening and this results in a progressive failure up the slope.

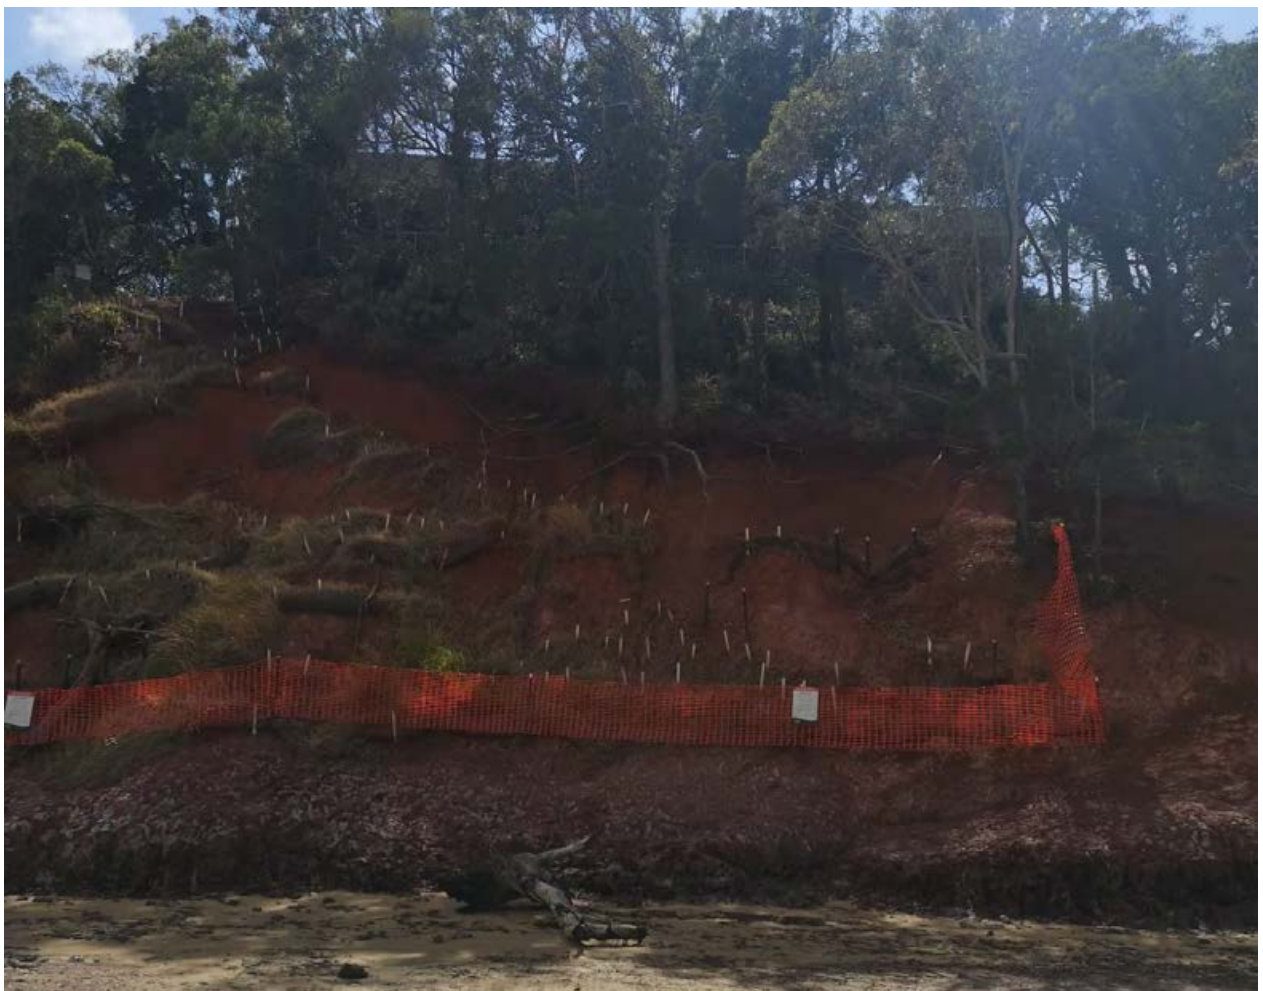
**Figure 3-11 Red Cliffs, BMT Site Inspection March 2019**

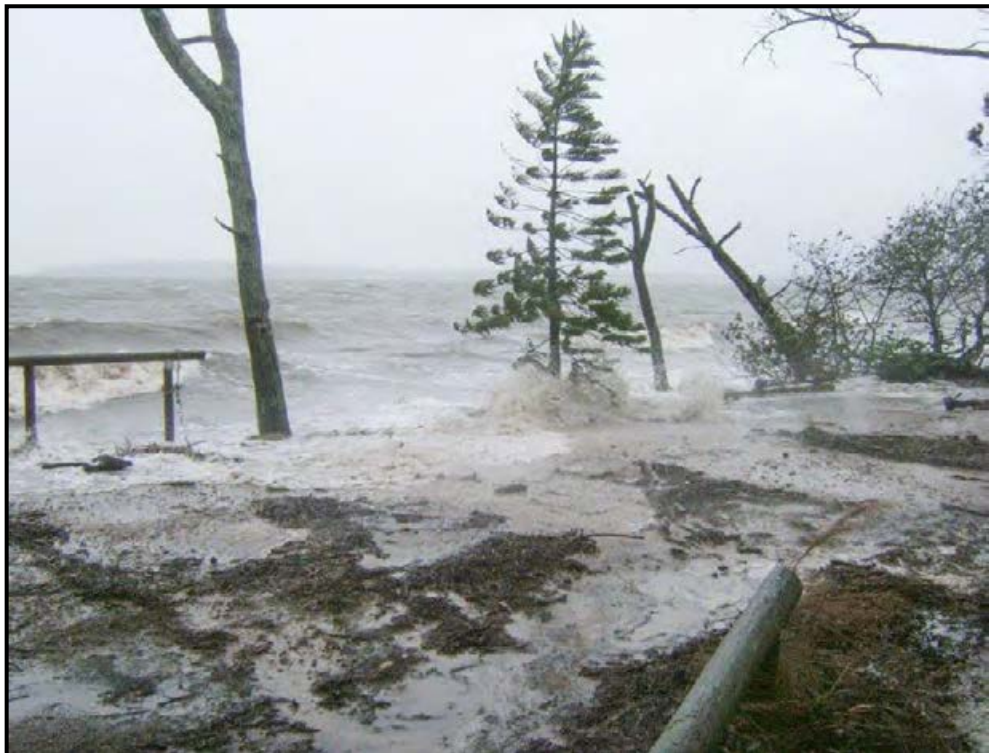
**Figure 3-14 Ex TC Oswald storm conditions at Norfolk Beach  
(Image courtesy of Coochiemudlo Island Coastcare)**

An indication of the tide height and wave conditions experienced at Coochiemudlo Island is shown in Figure 3-14 (image courtesy of Coochiemudlo Island Coastcare).

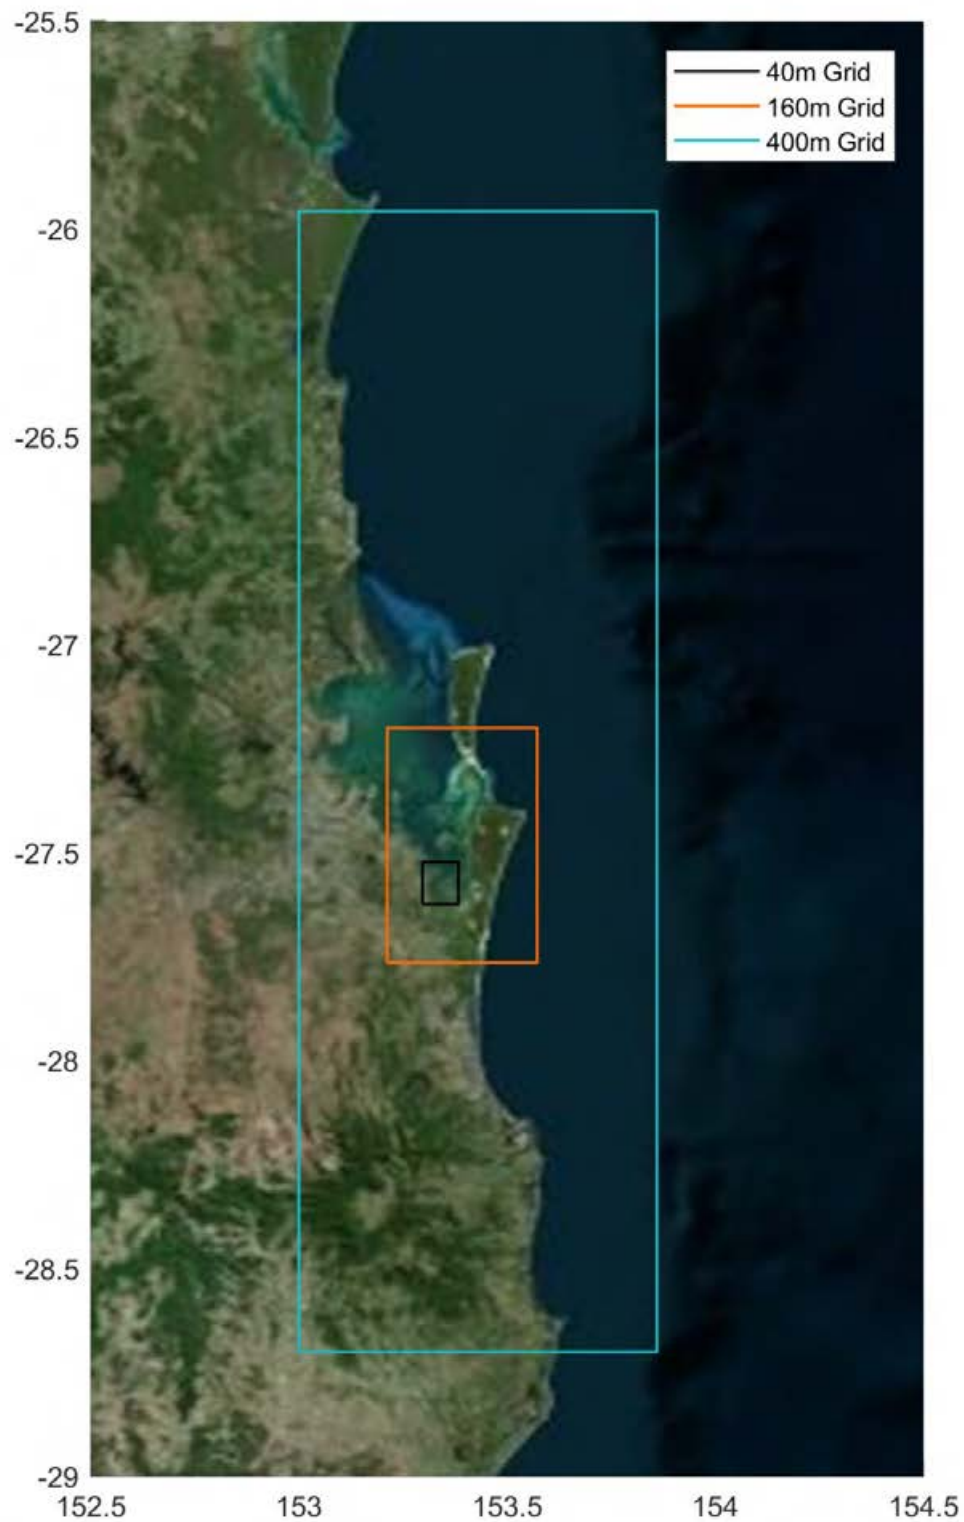
Figure 4-4 SWAN model nests

A nested-grid wave modelling approach has been adopted as shown in Figure 4-4. The nested system comprises a regional 400 m grid extending from the Gold Coast to the Sunshine Coast into deep water. Two smaller 160 m and 40 m nests were applied to improve the resolution of the waves inside Moreton Bay and around Coochiemudlo Island. A variable water level output from the hydrodynamic model has been applied to the 160 m and 40 m wave model nests to replicate tides.
