# **SOVEREIGN WATERS ESTATE**

## **Sedimentation Study**

**REDLAND CITY COUNCIL**

BEJ252-TD-MN-REP-0001 Rev. 0

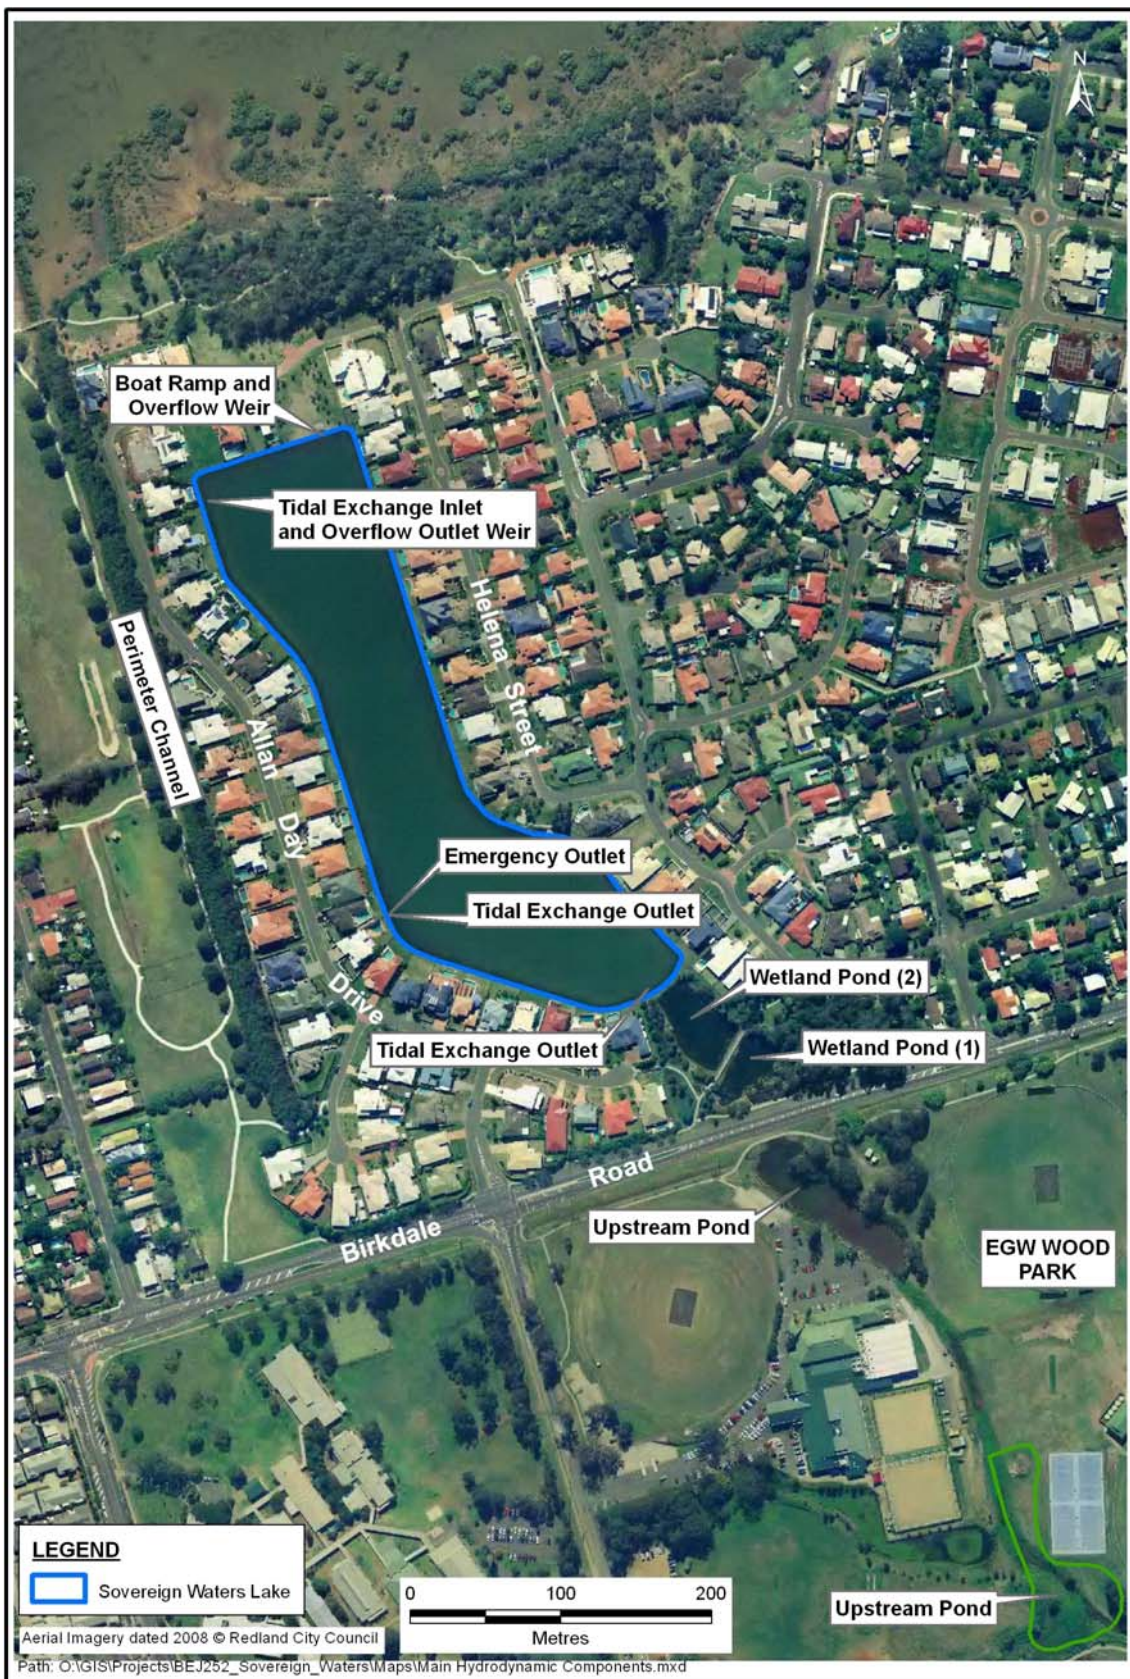
**Figure 1.2**  
**MAIN HYDRODYNAMIC COMPONENTS OF THE SOVEREIGN WATERS SYSTEM**

The Sovereign Waters lake and wetlands primary features can be seen in Figure 1.2 and are broken down into the following:

- upstream ponds (EGW Wood Park)
- two wetlands; 1 inlet zone and 1 macrophyte zone
- the lake
- boat ramp and overflow channel for flood events
- stormwater inlets and gross pollutant traps (GPTs)
- tidal exchange system which transfers via the adjacent perimeter channel.

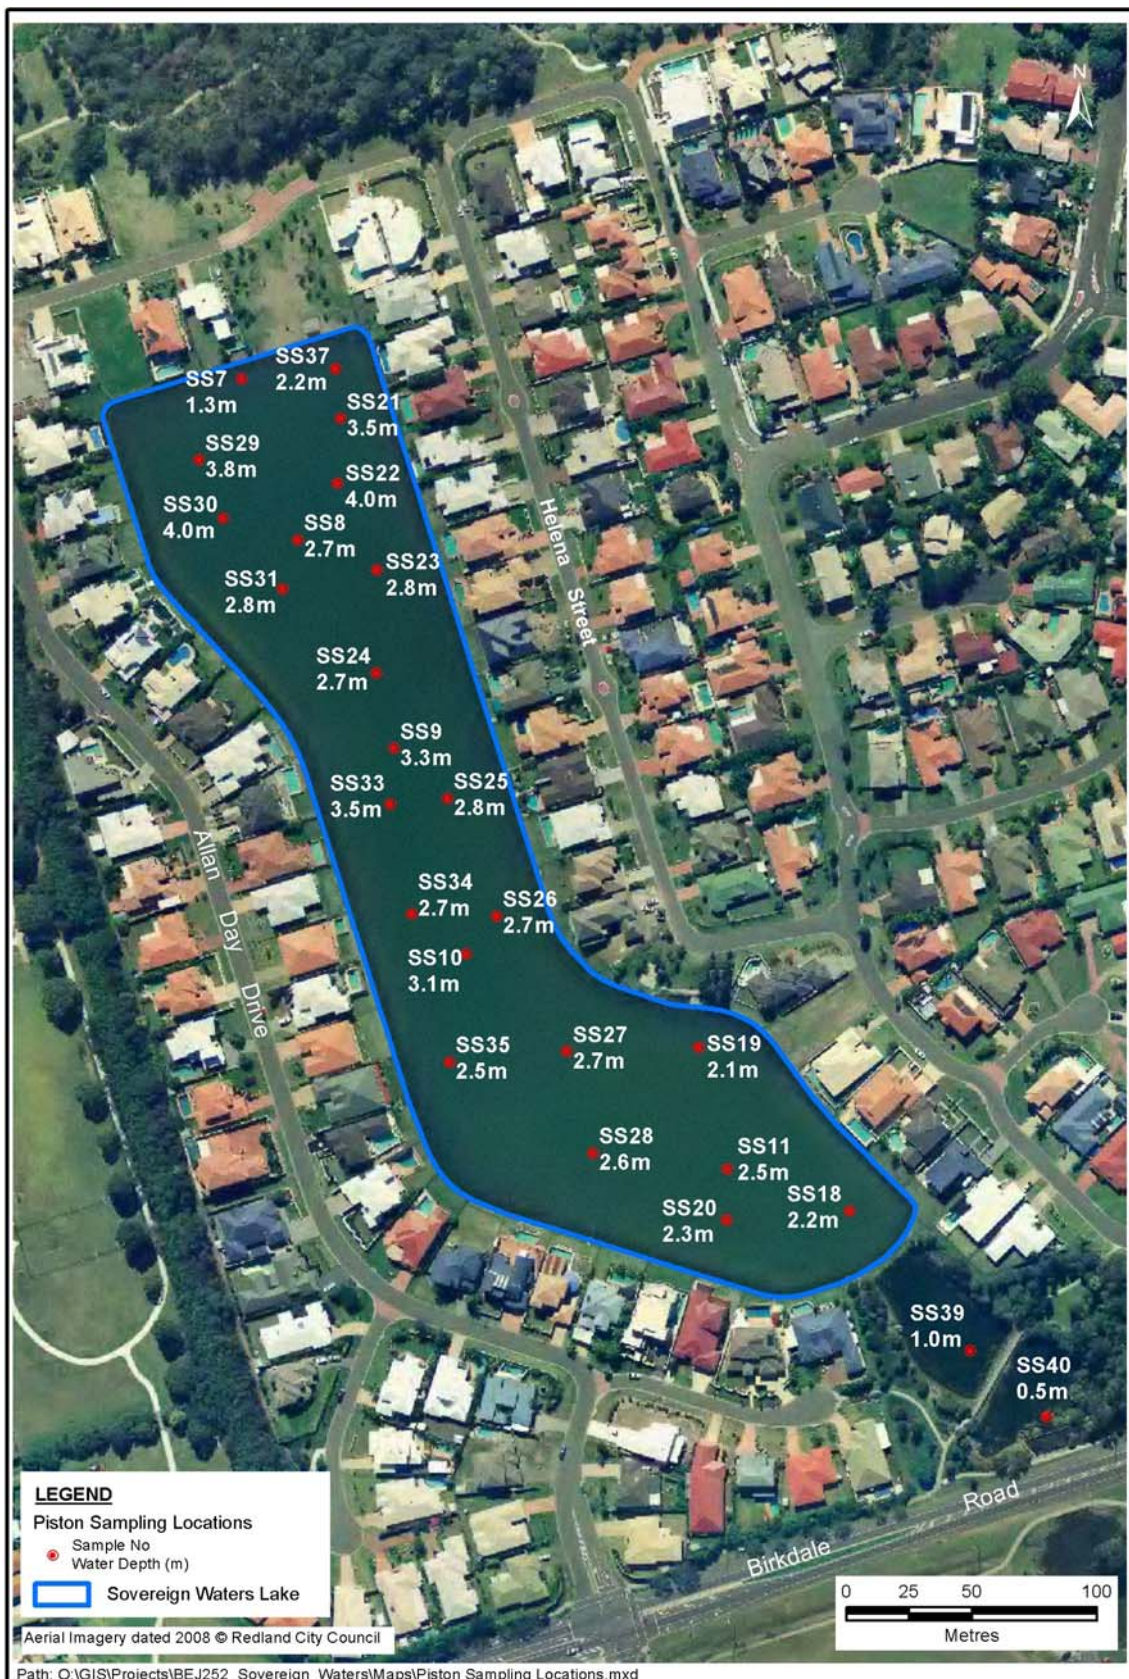
**Figure 2.1**  
**PISTON SAMPLING LOCATIONS**

Sampling of the both wetlands and the lake was conducted using a piston sampling method. Two sediment sampling events were completed.

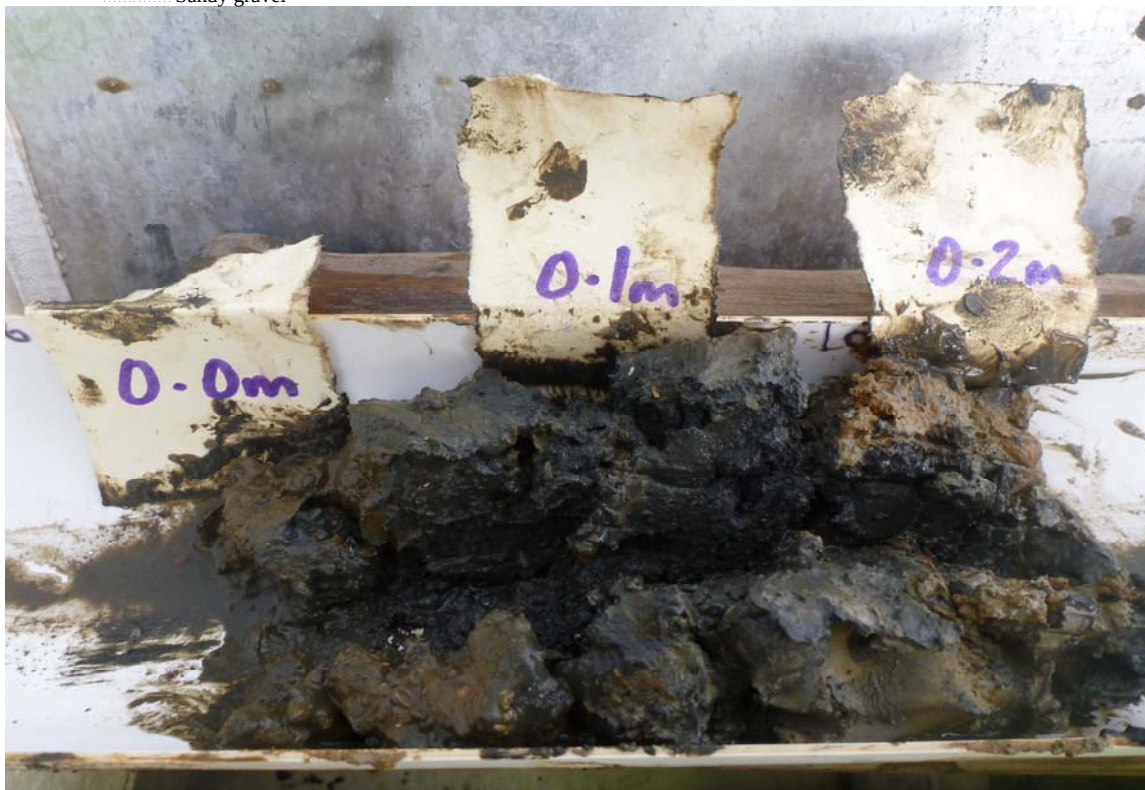
| CLIENT: | Redland City Council | Location: | SS 09 | Date: | 15/06/2012 |

| depth (m) | graphical log | Materials Description<br>soil or rock type: colour, particle size or plasticity, density, origin, other features, classification (Unified) | |
|---|---|---|---|
| -0.1 | | 0 - 0.15 | Gley 1 2.5/10Y greenish black. Fine silt, little cohesion, green/black, high moisture |
| -0.2 | | 0.15 - 0.40 | Gley 1 3/10Y very dark greenish grey. Fine silt, little cohesion, green/dark grey, high moisture |

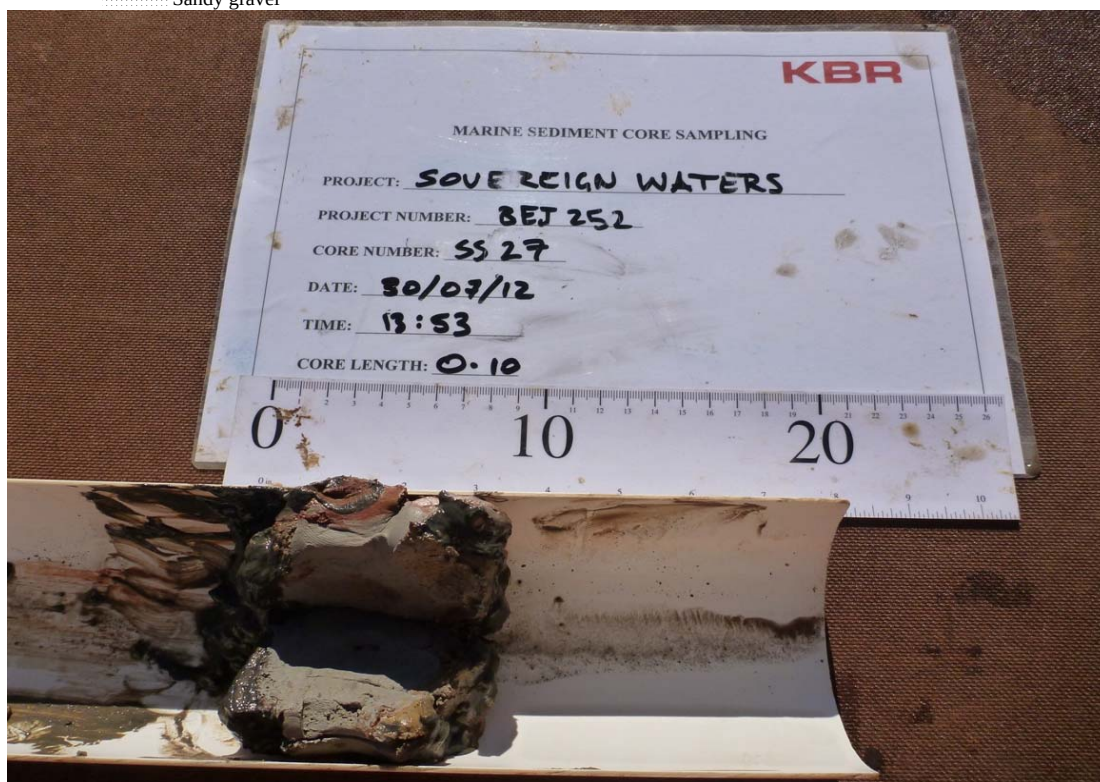
| CLIENT: | Redland City Council | Location: | WP43 | Date: | 30/07/2012 |

Note: 2 samples taken, the first had more silt but did not extrude correctly - one side remained in the sampler, had approx 3.5cm of silt. Second sample (above) had very little.
