# **RABY BAY CANAL BATTER STABILITY UPDATE**

## **Geotechnical Investigation Analysis Report**

**REDLAND CITY COUNCIL**

BEJ809.002-W-REP-003 Rev. 0

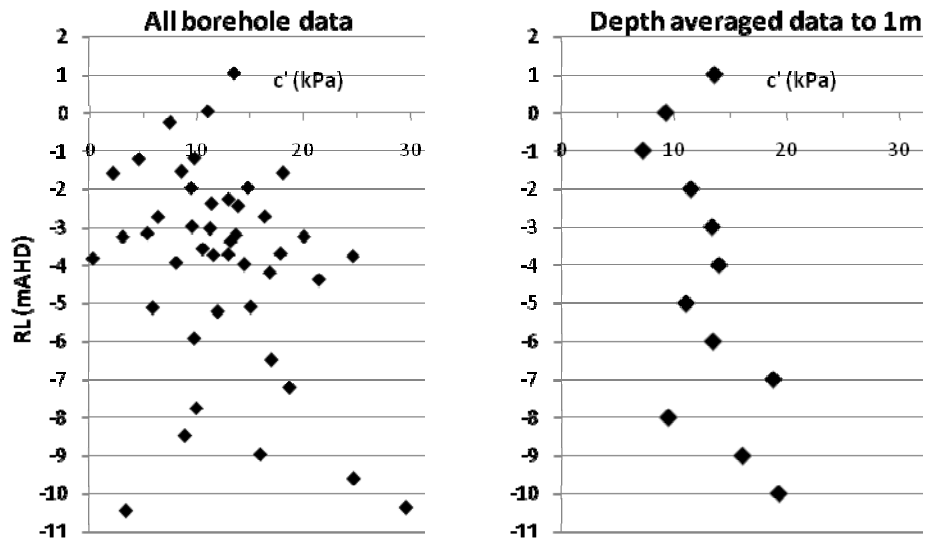
**Figure 2.4**  
**UNDRAINED SHEAR STRENGTH MEASUREMENTS FROM DILATOMETER TESTS**

Soil density, pore water pressures, cohesion and friction angle values are the main properties that affect slope stability. Figure 2.4 shows two plots of undrained cohesion values  $c_u$  with respect to depth. The first plot includes all data from the dilatometer tests, while the second shows these values averaged over 0.5 m bins. It is important to note that there is a significant increase in average recorded shear strength at approximately  $-4.0$  mAHD. This is consistent with the typical level where lateral displacement is first observed in the borehole displacement records in Figure 2.2. It is inferred that this is near the level where very stiff clay was encountered after soft overlying material was removed during construction.

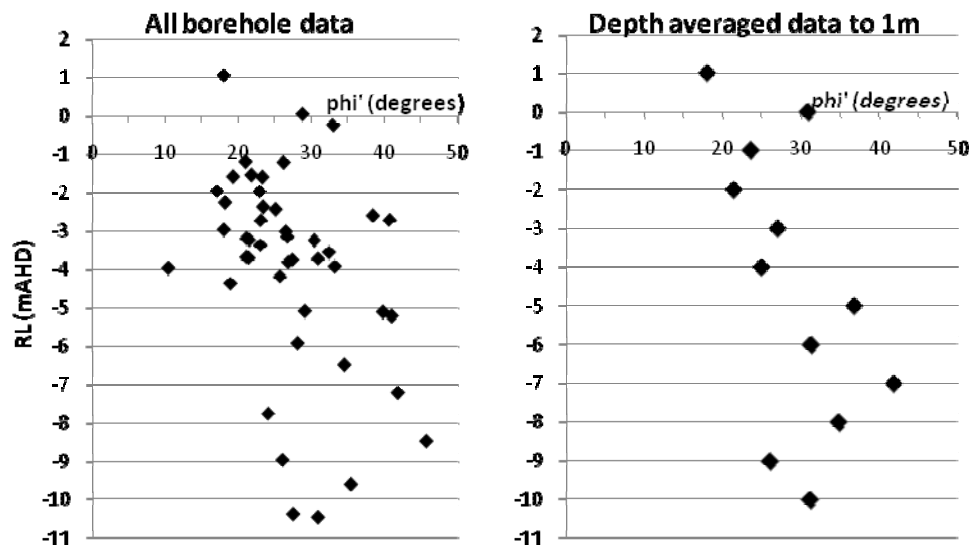
**Figure 2.5**  
**DRAINED SHEAR STRENGTH VALUES FROM TRIAXIAL TESTS**

Note that the tested shear strength of the stiff clay can be affected by the presence / absence of fissures in the test samples (Bowles 1988, p81)

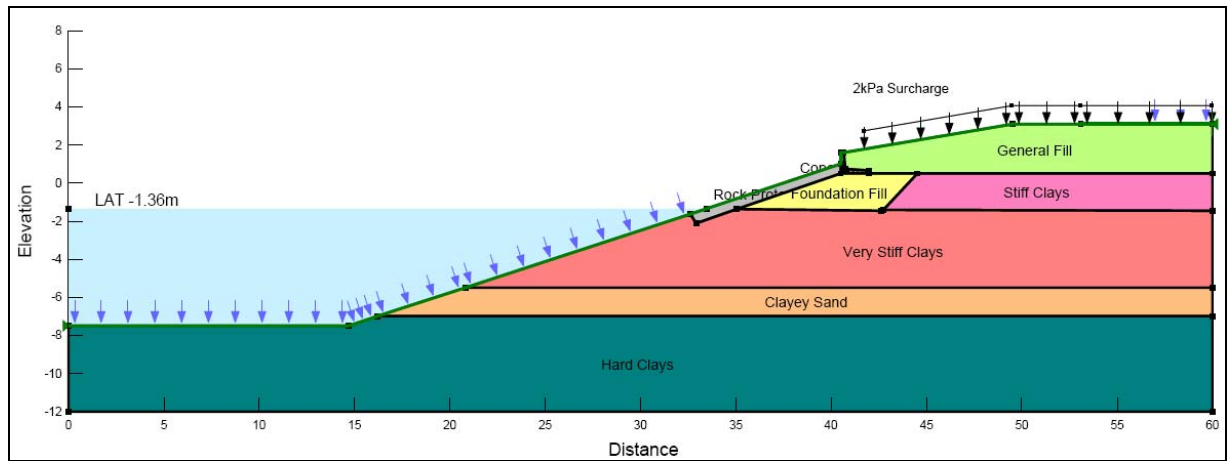
**Figure 3.1**  
**SLOPE/W MODEL LAYOUT**

The Slope/W model is shown in Figure 3.1. The assumed soil strength parameters are shown in Table 3.1.

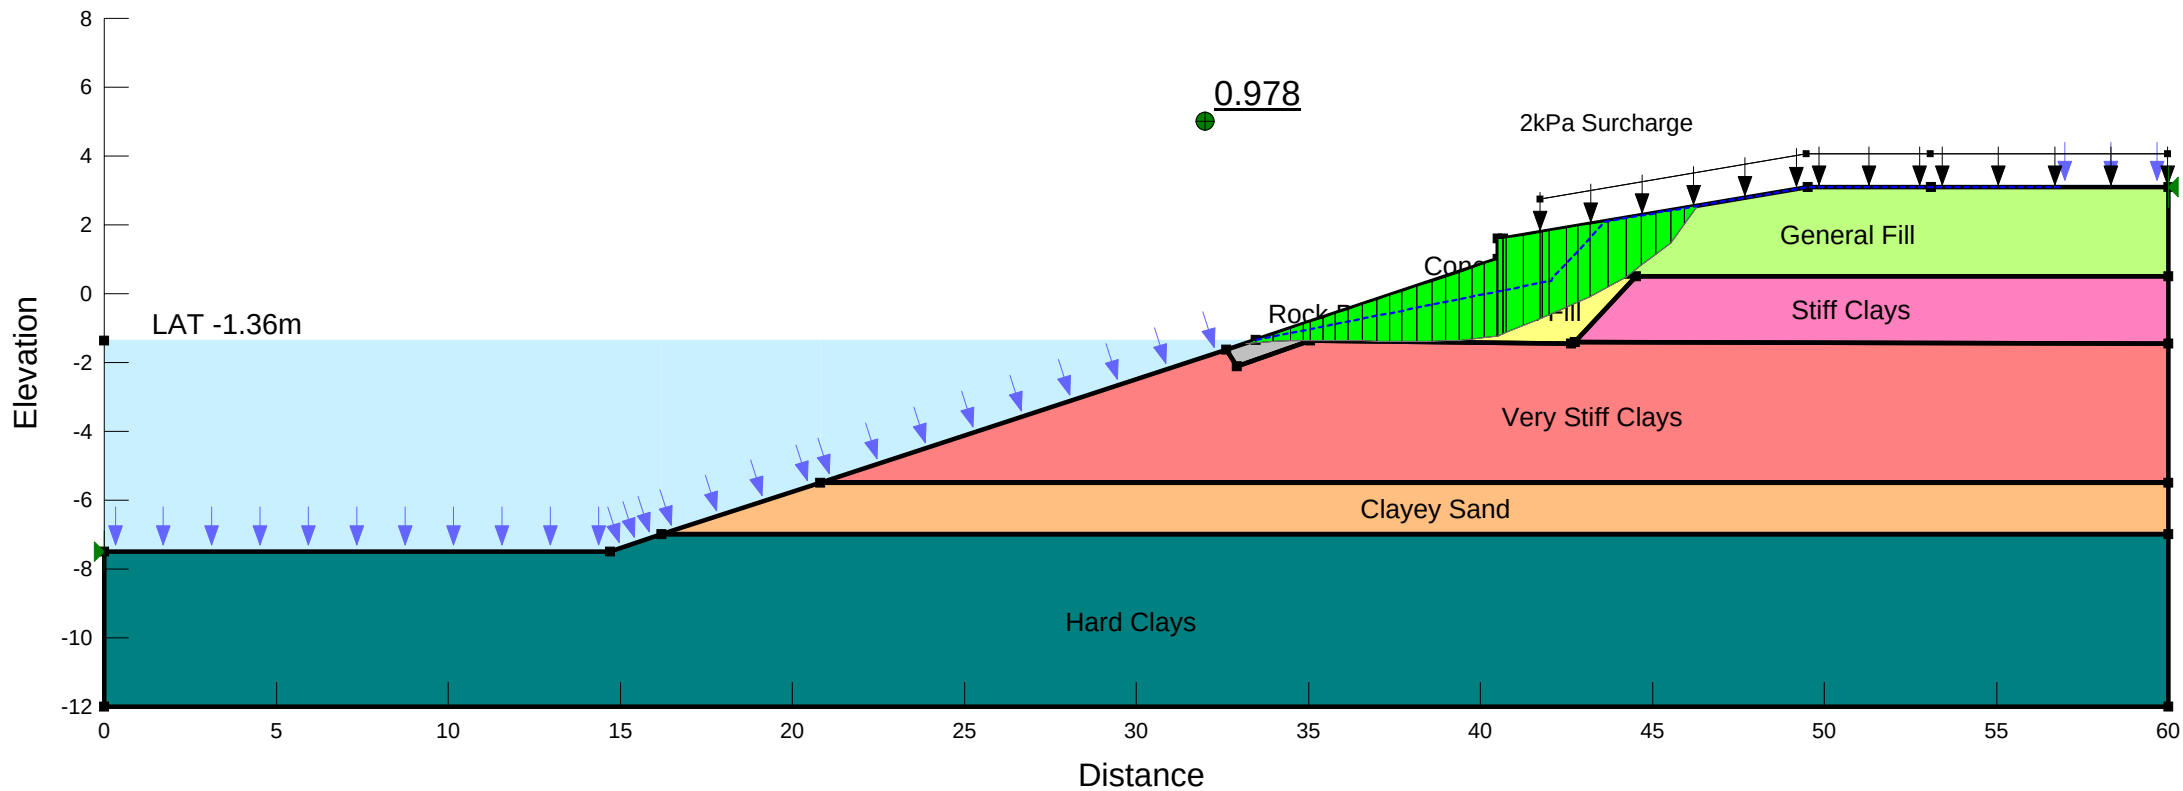
## Model: Critical Slip Failure

The critical slip surface is shown in Figure 3.2. The authors believe that the model result is consistent with the surface observation of slope failures in Raby Bay; a shallow slip surface through the weak wedge of uncompacted fill behind the rock protection. Borehole data indicates lower shear strength in this region. A hypothetical deep slip failure mode doesn't appear to be critical, nor has it been observed in the field by the writers.

| Case | FOS | Figure | Type of failure |
|---|---|---|---|
| Critical slip failure for approximated current slope | 0.978 | 3.2 | Shallow slip failure through fill material |

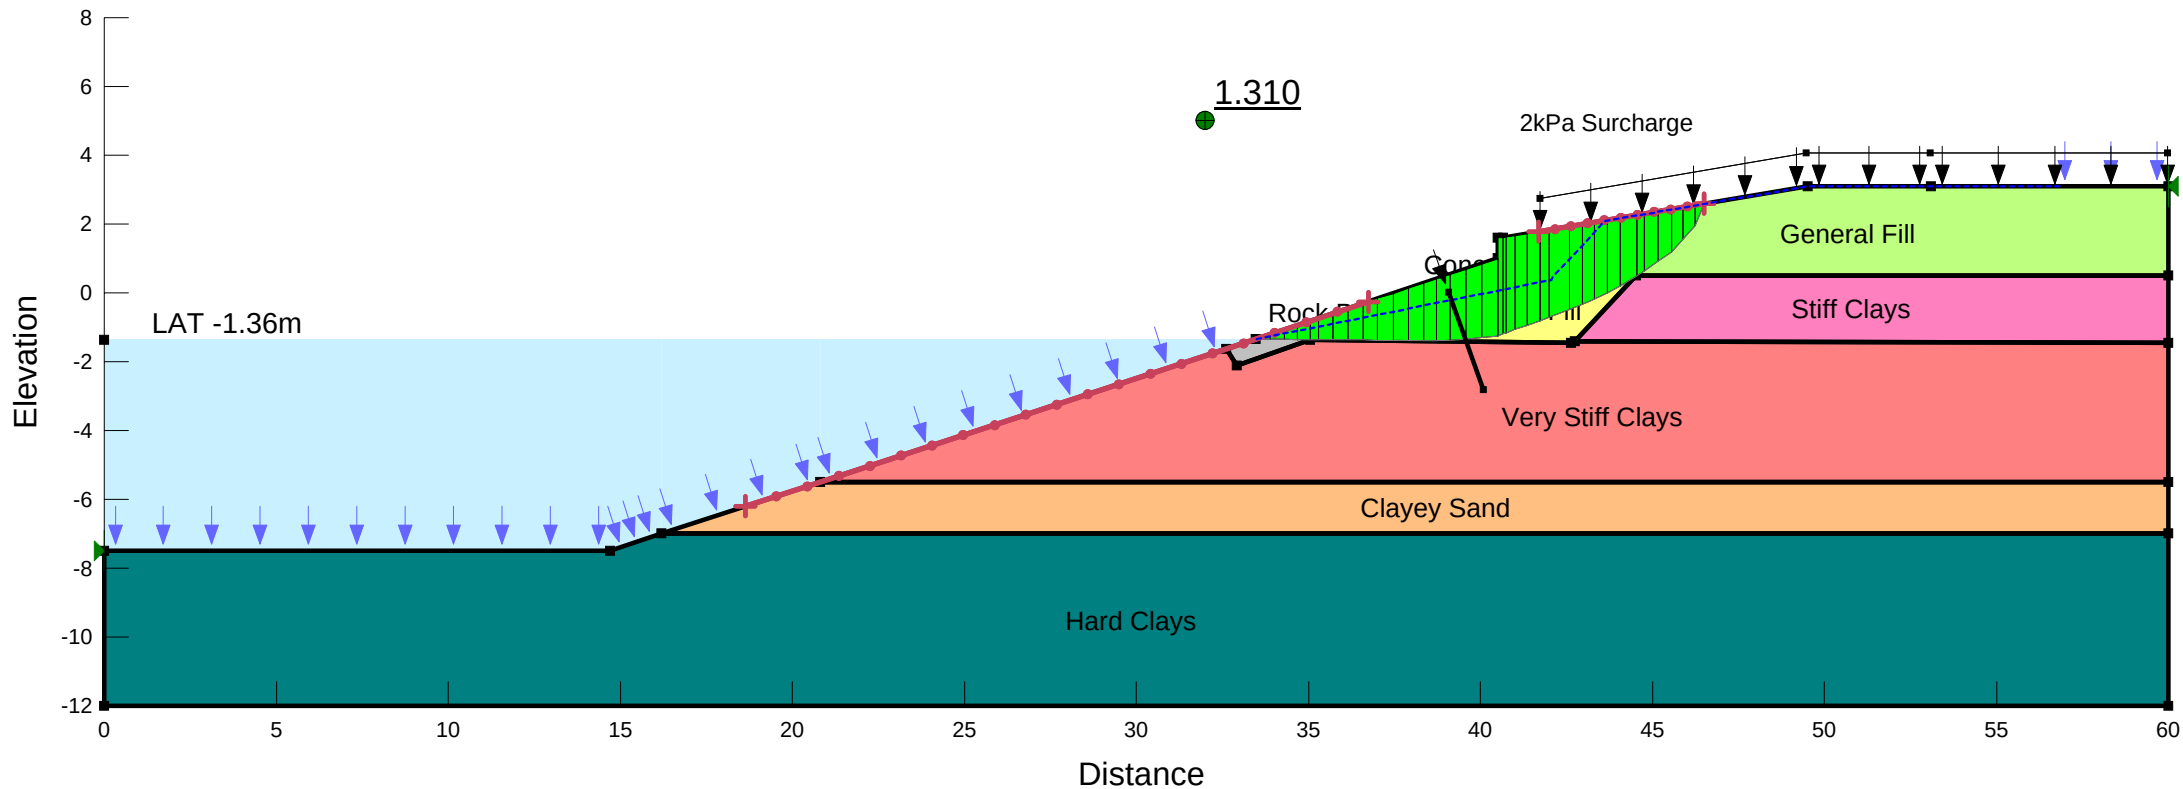
## Model: 3m Grout Piles at 2m crs

| Case | FOS | Figure | Type of failure |
|---|---|---|---|
| 3 m grout piles at 2 m spacing (0 mAHD) | 1.310 | 3.4 | Shallow slip failure through piles in fill material |

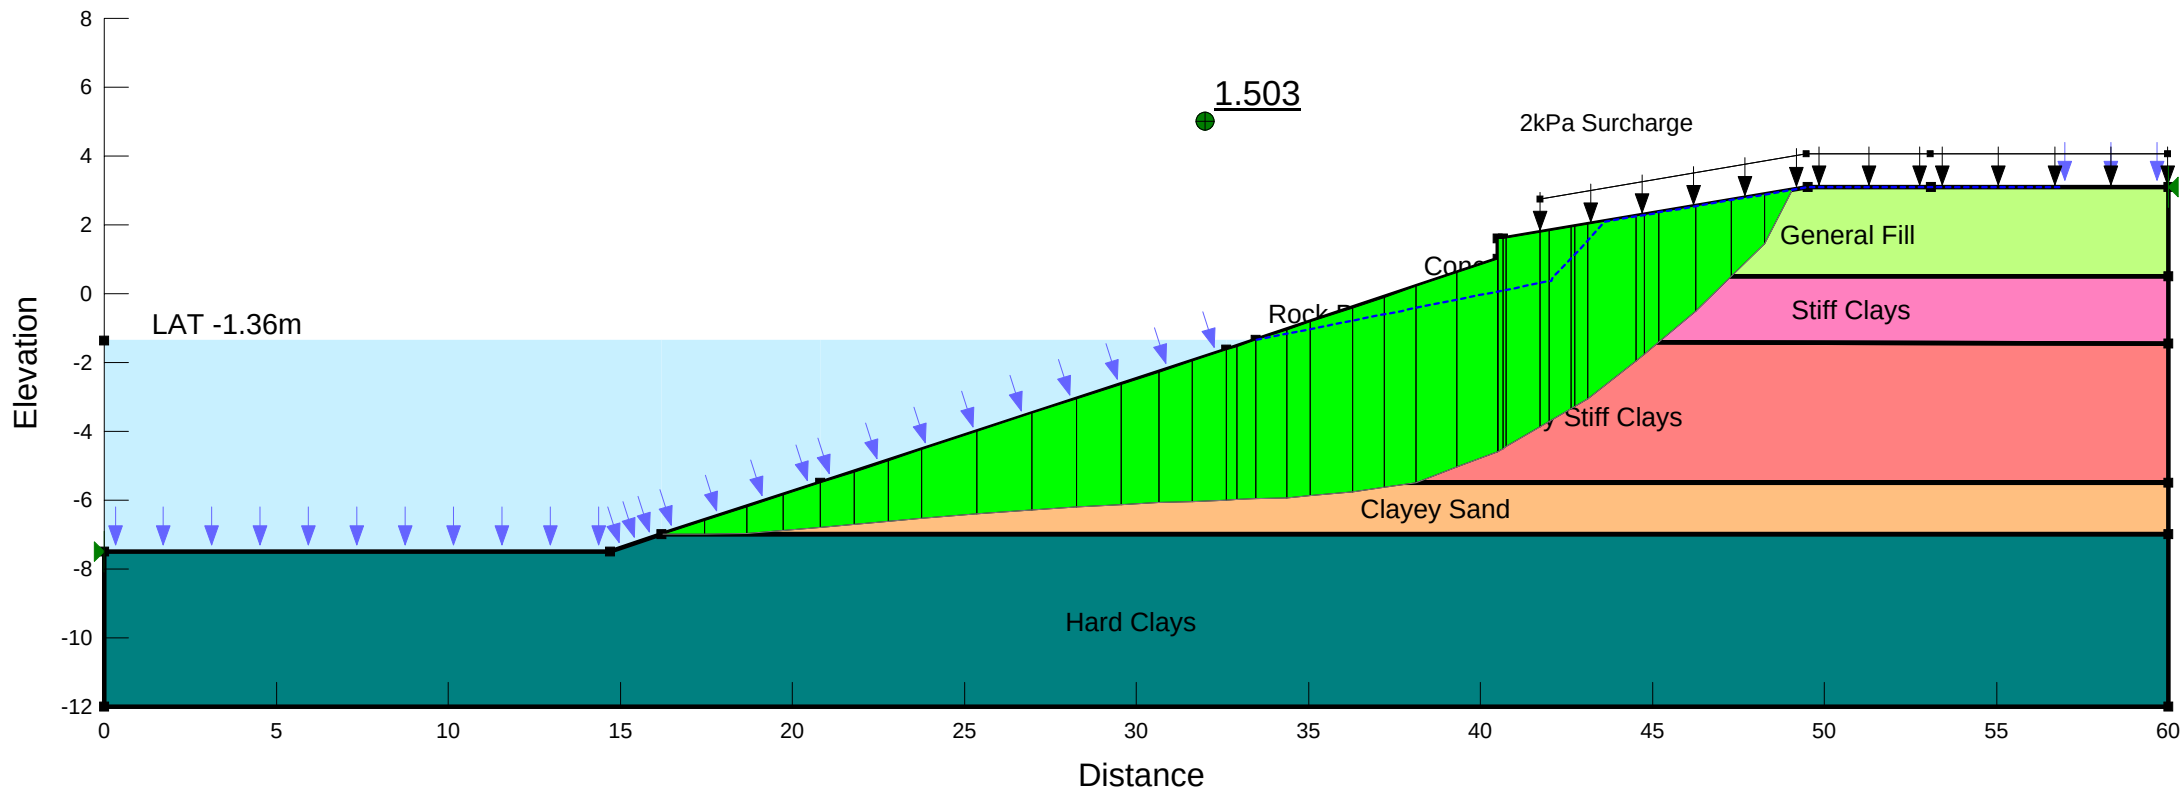
## Model: Deep Failure

| Case | FOS | Figure | Type of failure |
|---|---|---|---|
| Check for deep slip failure | 1.503 | 3.3 | Deep slip through toe of slope |

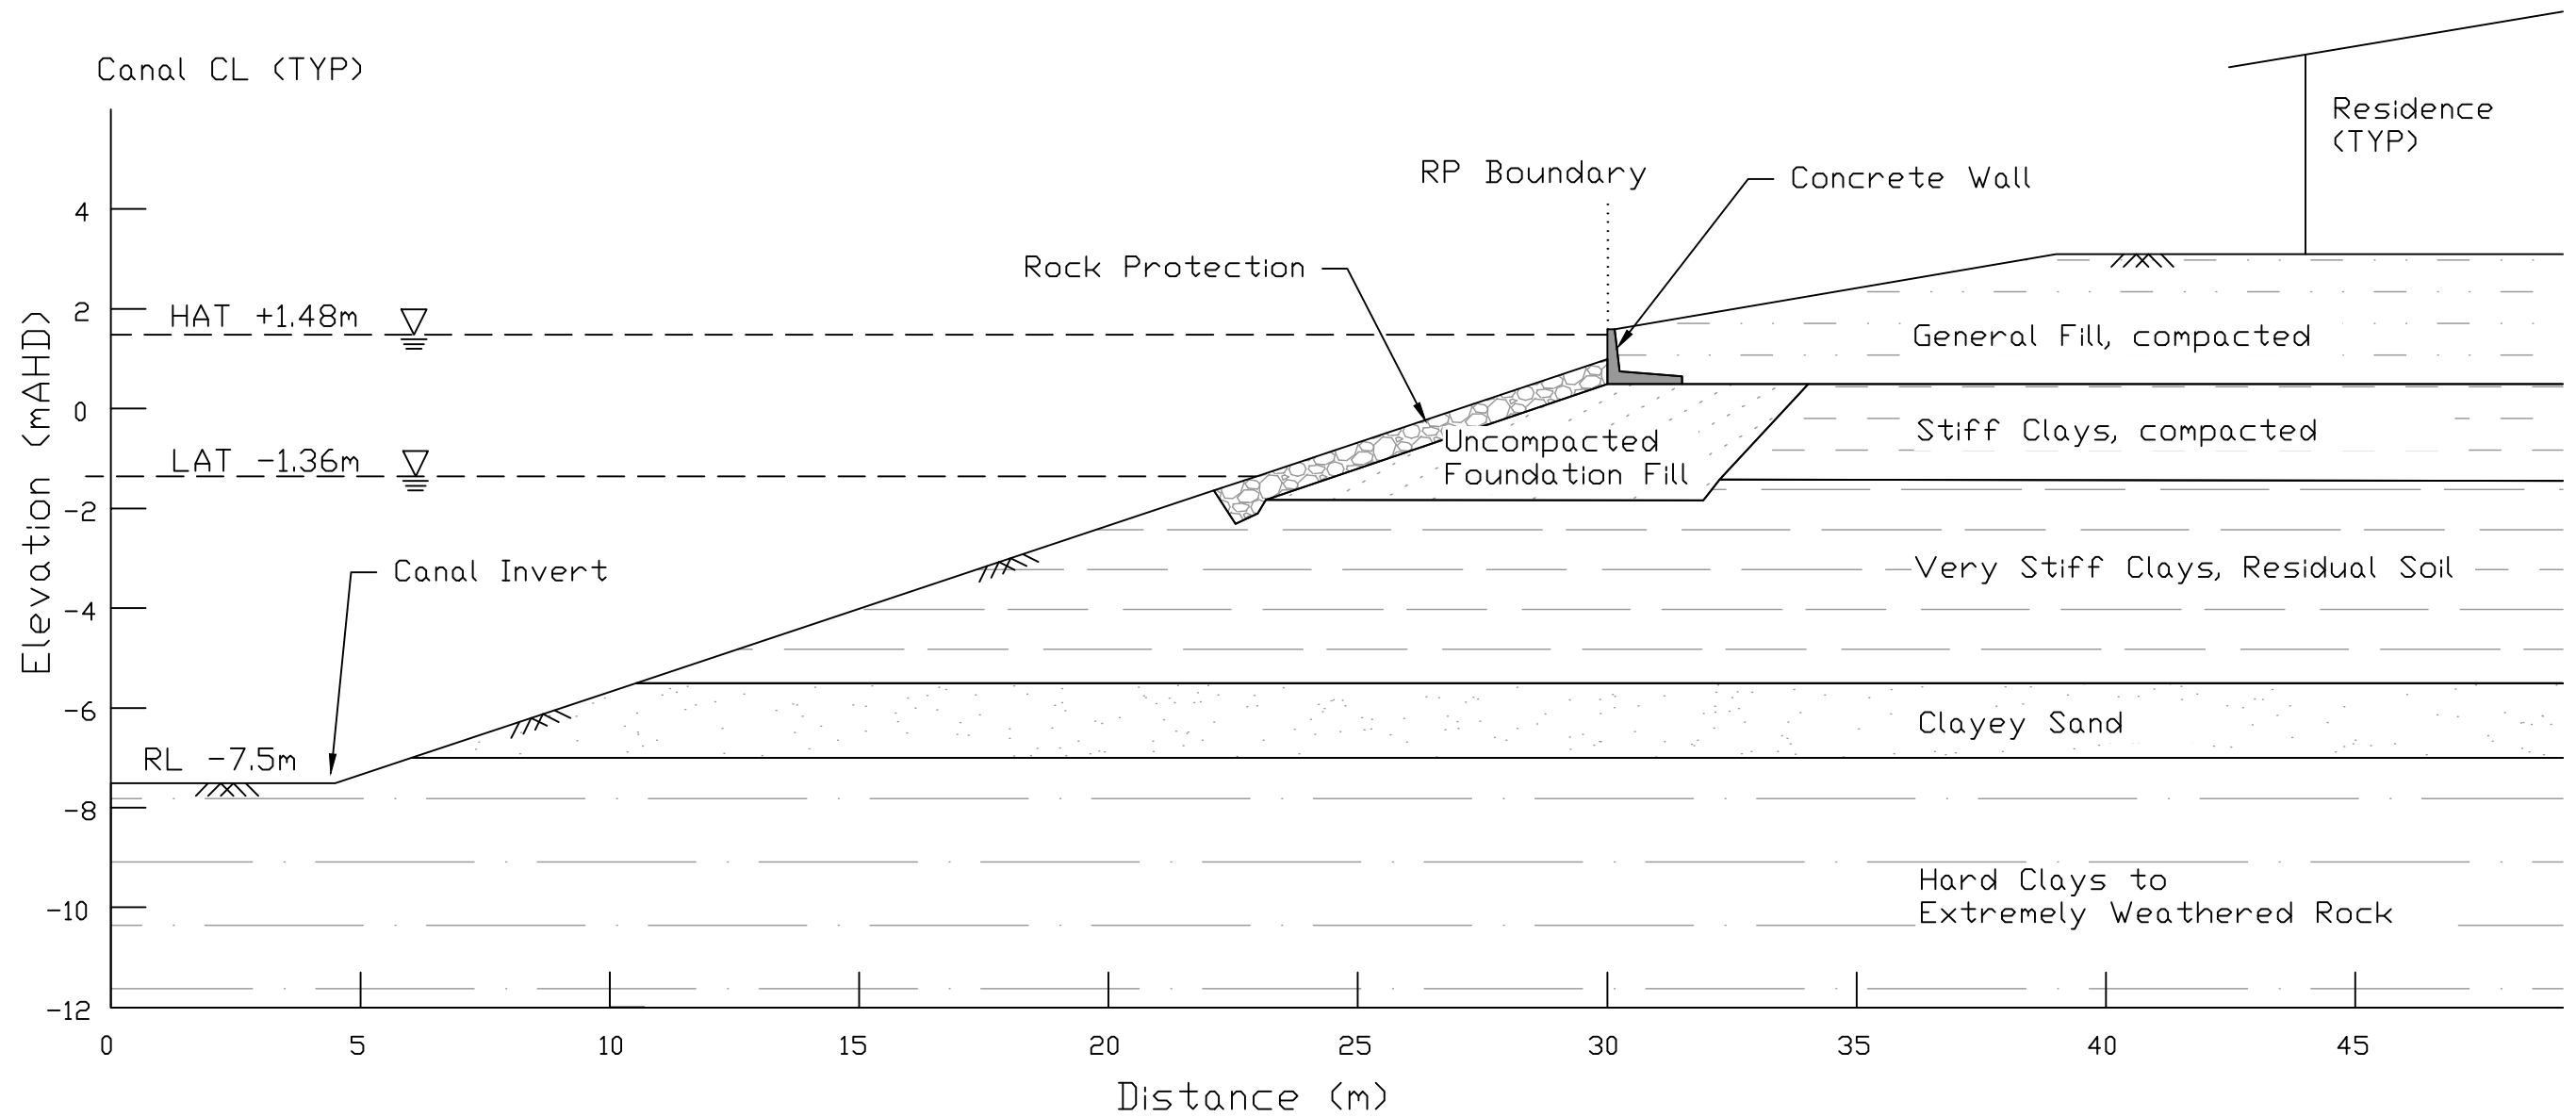
Figure 2.1 SIMPLIFIED SOIL PROFILE LAYOUT

Relying mainly on the borehole data and the simplified soil profile of the Piermont Place slope in report 1-14061BR, the soil profile as shown in Figure 2.1 is believed to be typical of Raby Bay. This soil profile layout has been used for the basis of the slope stability calculations in Chapter 3.

Figure 2.1 is based on construction drawings, Soil Surveys report and KBR interpretation. An A3 copy of this diagram is included in Appendix C.

Based on Construction Drawings, Soil Surveys Report and KBR Interpretation
