# Assessment of Erosion Mitigation Options

Amity Point SEMP

Redland City Council

## Amity Point Shoreline Erosion Management Plan Interim Report – Assessment of Erosion Mitigation Options

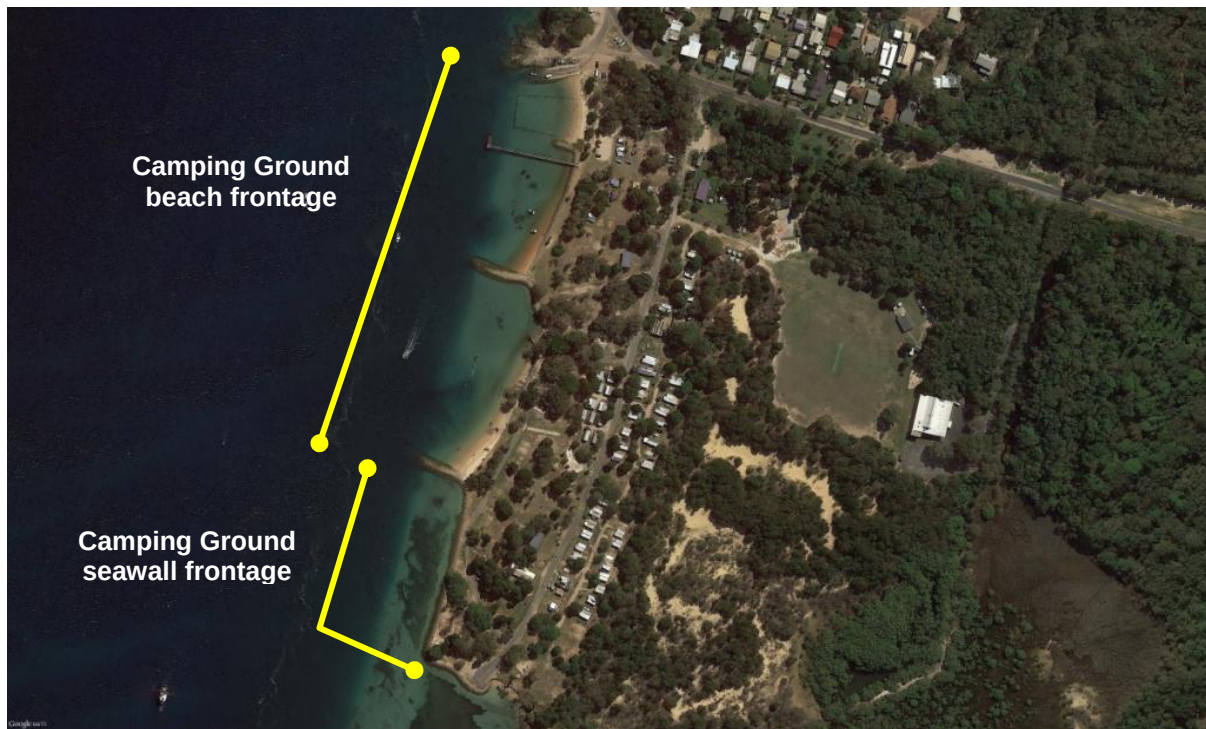
FIGURE 2-1 SOUTHERN PRECINCT – CAMPING GROUND FORESHORE

Due to the different type and orientation of the shoreline at the southern-most end of this foreshore (at the end of Basin Drive), there is scope to further refine the partitioning within this precinct. As shown on Figure 2-1 the southern precinct consists of an approximately 355 metre long beach frontage to the camping ground; and a 215 metre long rock-armoured seawall bordering the southern part of the reserve.

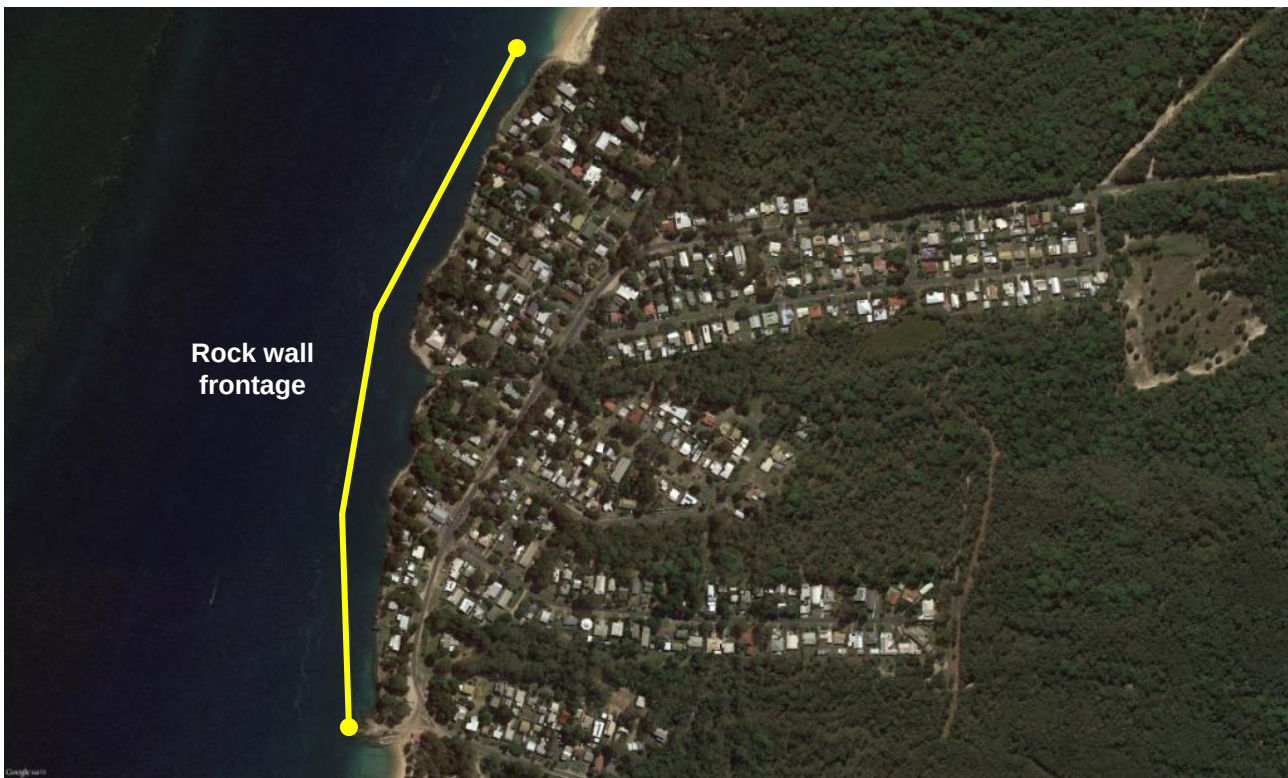
FIGURE 2-2 CENTRAL PRECINCT – ROCK WALL FRONTAGE

The Central Precinct consists of the existing rock wall frontage extending northwards from the boat ramp at Claytons Road to near the northern end of Millers Lane (refer to Figure 2-2). This rock structure is a flow slide barrier that has been progressively reinforced by local property owners over many years. The erosion threat along this Central Precinct is primarily as a consequence of discrete flow slides (or retrogressive breach failures) in conjunction with the processes causing Rainbow Channel to slowly migrate eastward.

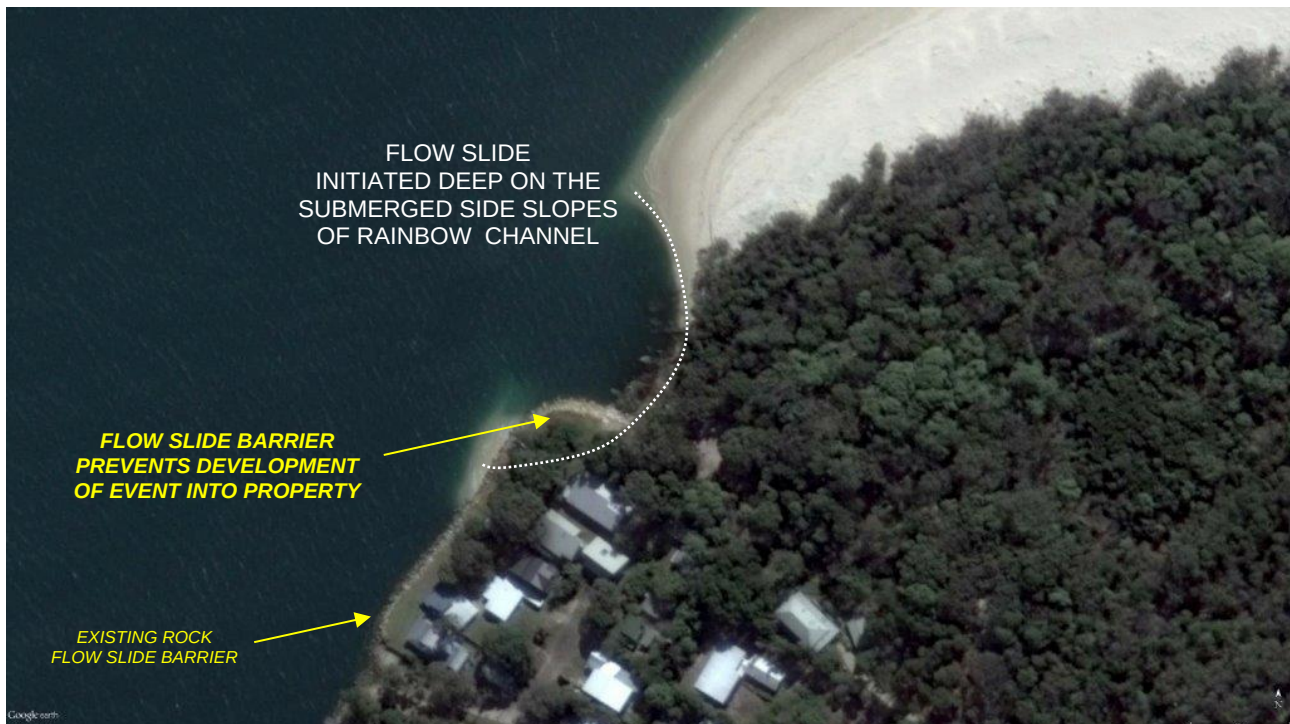
**FIGURE 2-3 EXISTING FLOW SLIDE BARRIER INHIBITING DEVELOPMENT OF FLOW SLIDES**

The flow slide event depicted in that figure has developed and penetrated into the unprotected sand foreshore to the north, but the existing rock barrier that has been progressively built on the frontage of the private property has prevented the flow slide developing into the land behind and on top of it. It is evident that the existing flow slide barrier is effective in limiting the development of the frequent flow slides that occur on the submerged side slopes of Rainbow Channel from developing into destructive events.

However, this barrier function would only be maintained provided that the current practice of recharging the upper reserves of rock in the structure occurs whenever there is local undermining of the barrier. A focus of work to be undertaken in future Stages 4 and 5 of the SEMP will be the determination of the vulnerability of the existing flow slide barrier to future flow slide events. A geophysical survey currently underway to determine the extent of the rock buried in the Amity Point foreshore will significantly assist in that determination.

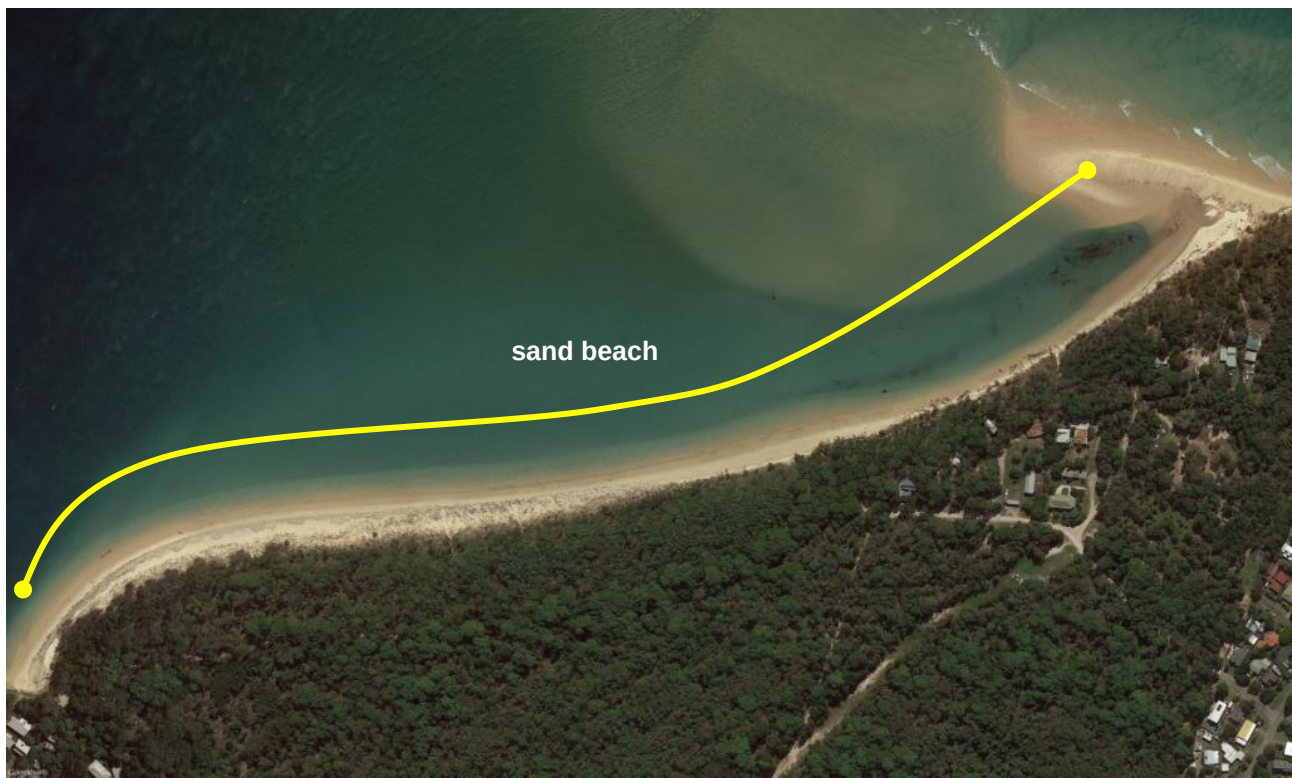
FIGURE 2-4 NORTHERN PRECINCT – AMITY BEACH

The Northern Precinct consists of the sandy Amity Beach foreshore extending from the northern-most end of the Central Precinct's flow slide barrier, to the prograding sand bar feature at the western end of Flinders Beach (refer to Figure 2-4). The erosion processes along Amity Beach are due primarily to the changing sediment transport regime driven by the wave climate, in conjunction with the shifting and complex bathymetry of South Passage immediately offshore.
