# **AQUATIC PARADISE CANAL ESTATE**

## **Siltation Study**

**REDLAND CITY COUNCIL**  
PO Box 21  
CLEVELAND QLD 4163

BEJ253-TD-MN-REP-0001 Rev. 1

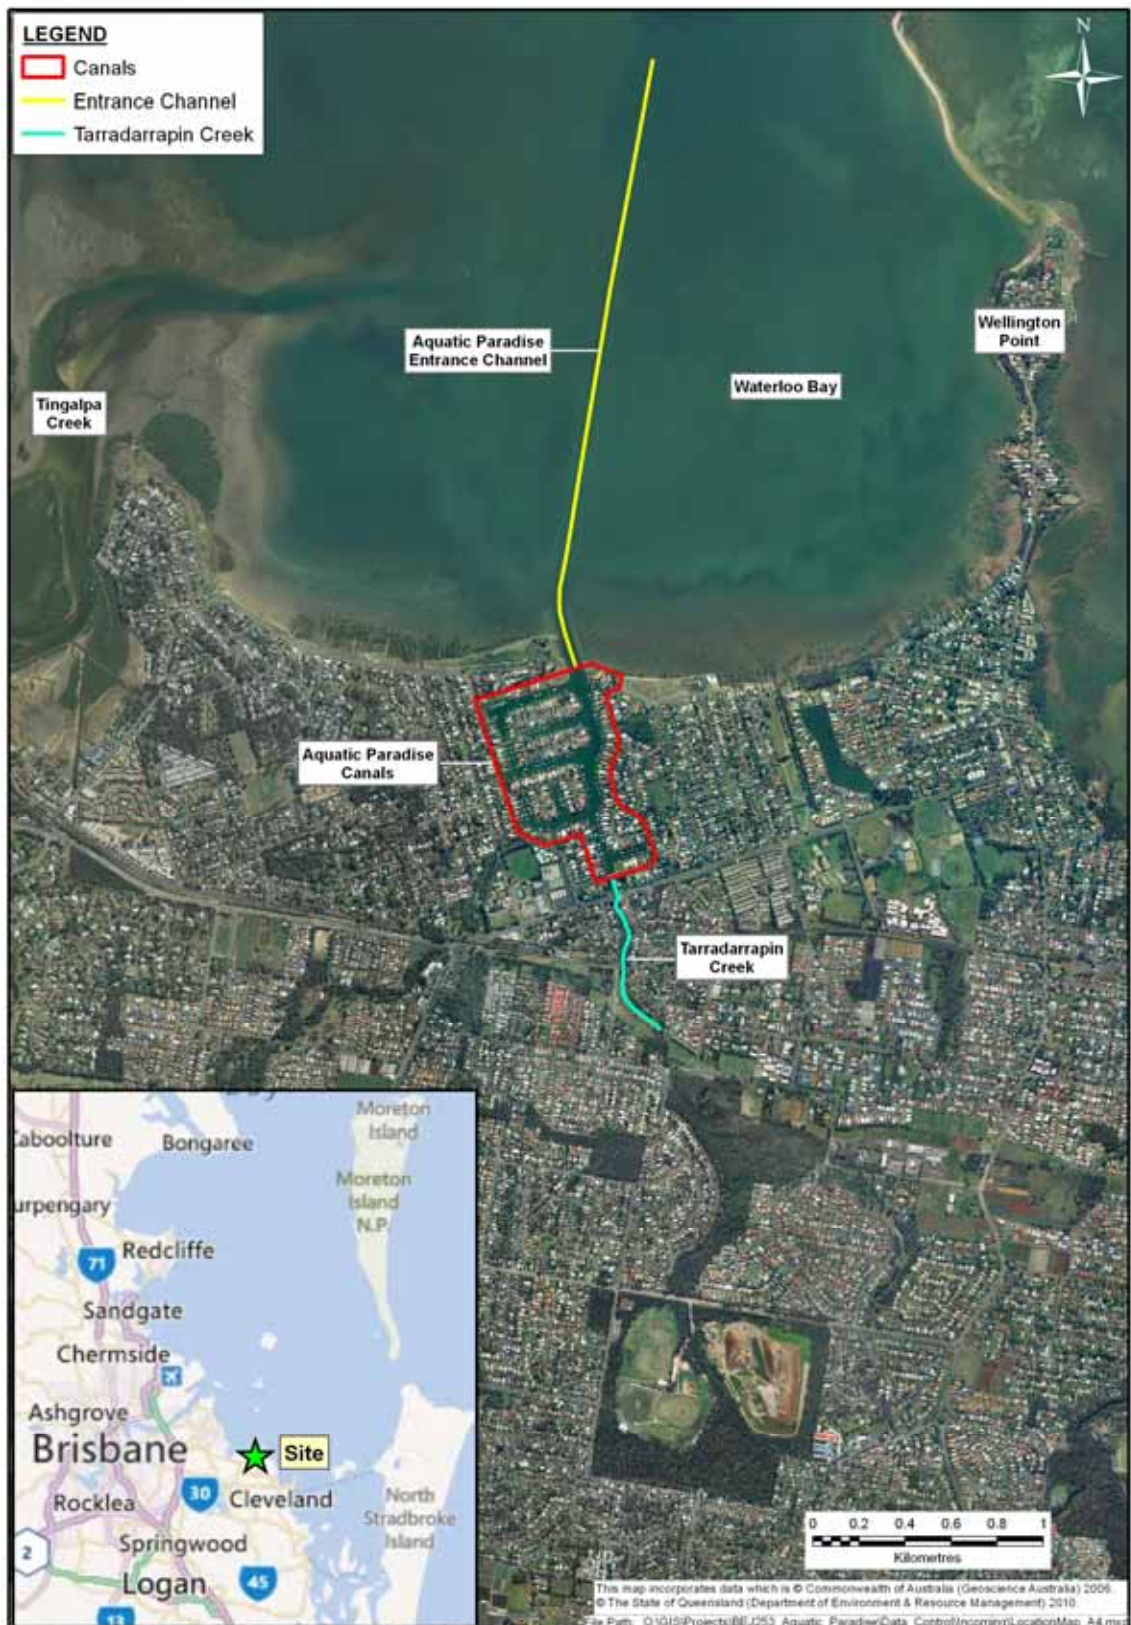
**Figure 2.1**  
**LOCATION**

The location of the Aquatic Paradise canal system is shown in Figure 2.1. This aerial image displays the canals and entrance channel with the canal estates broader locality being shown on the key map.

The canal system is located in Birkdale on the southern side of Waterloo Bay, which forms part of the greater Moreton Bay. The estate comprises approximately 3,000 m of inshore canals with a 2,950 m long access channel extending north into Waterloo Bay.

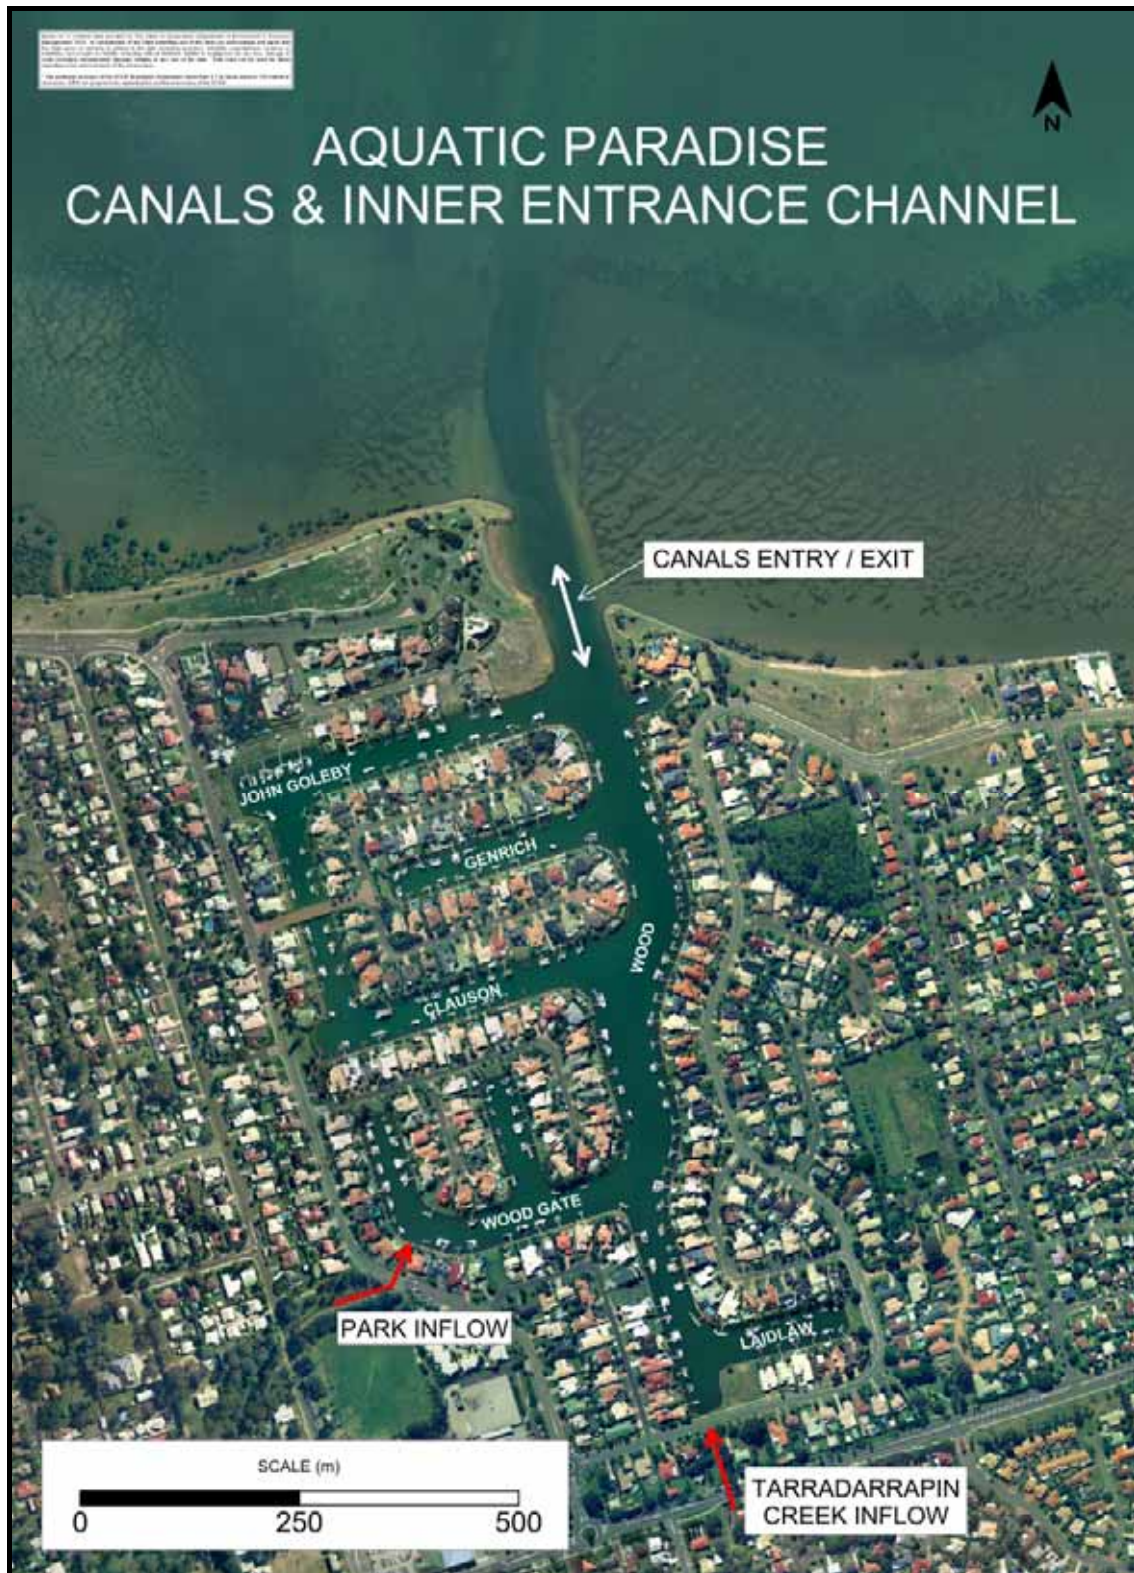
Figure 2.2  
CANALS LAYOUT

Figure 2.2 is a close-up aerial image showing the layout of the canal system. There is only one entry/exit point for boat traffic, but there are a number of stormwater inflow points. The main source of runoff into the canals is Tarradarrapin Creek, which flows into the system at the southern end of Wood Canal. The canal estate has a total catchment area of approximately  $4.5 \text{ km}^2$ , of which approximately 85% is suburban development, 5% is playing fields and parks, and the remainder is bush and wetland. In addition to Tarradarrapin Creek there are also three relatively large culverts which discharge into Wood Gate Canal, from William Taylor Park and the nearby cricket ground. Various other minor stormwater outlets also drain into the canals at locations throughout the system. In recent years RCC has installed sediment traps on some stormwater drains which flow into the canal system as a trial program.

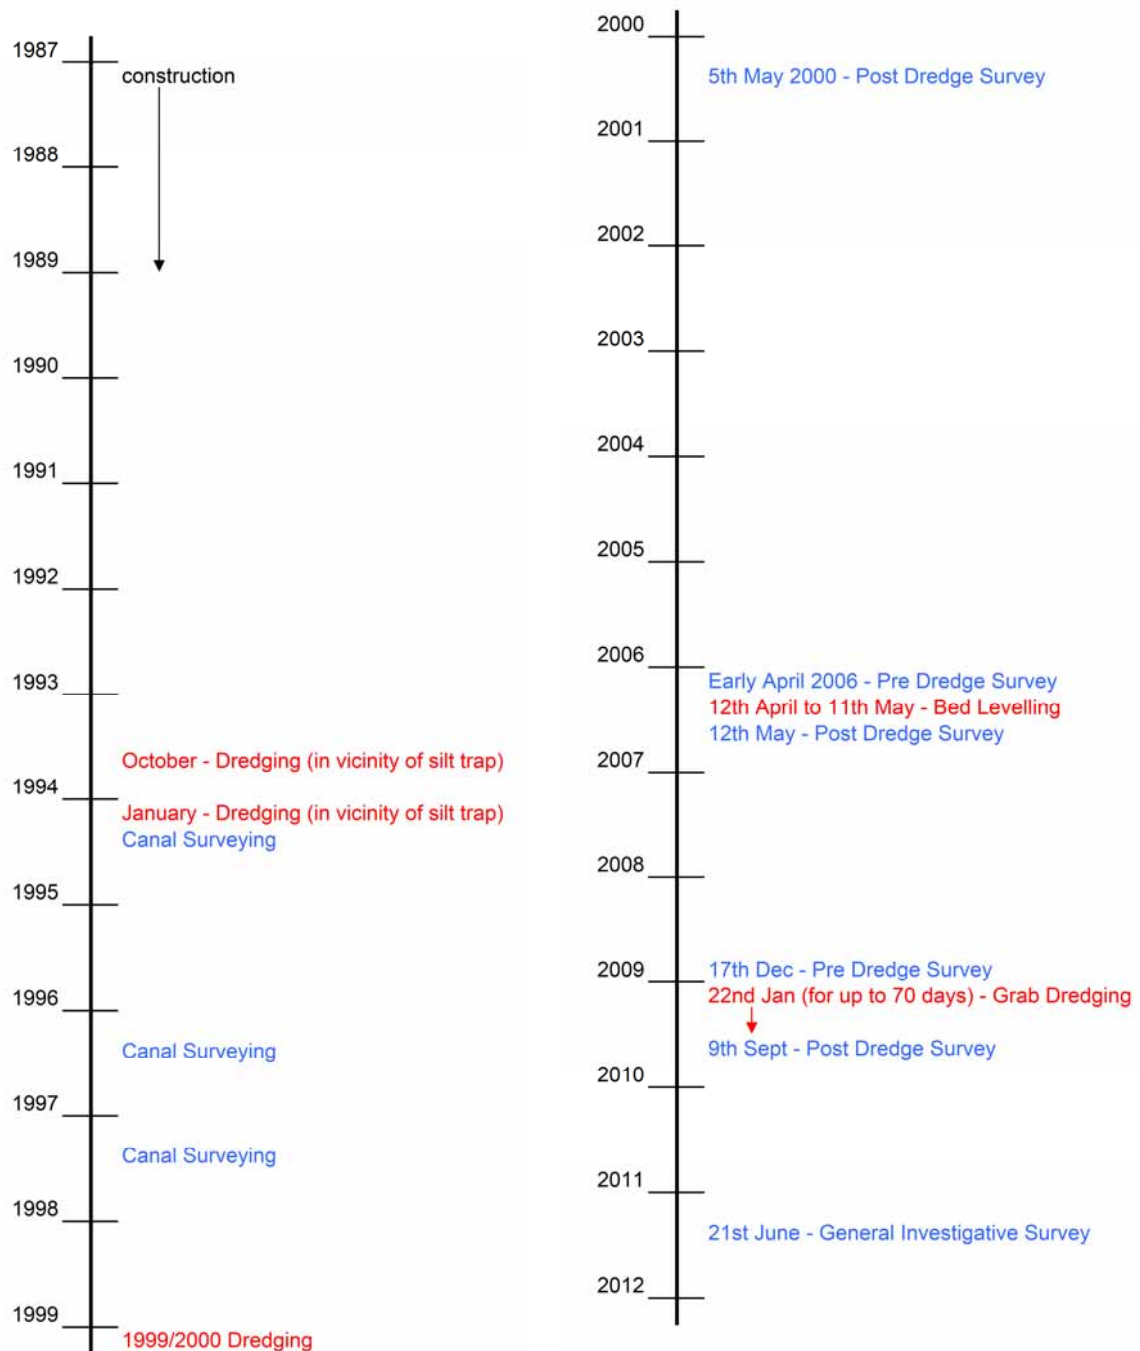
**Figure 2.3**  
**SURVEYS AND DREDGING OCCURRENCES**

Since the canal system’s construction in 1987–88 there have been various surveys and dredging campaigns undertaken. In order to assess siltation, KBR needed to identify and quantify dredging campaigns between surveys. The timeline set out below indicates times when KBR has information that dredging and surveying has occurred. Dredging is shown in red text and surveying in blue.

*Note: The 'silt trap' is located between chainage 0m and 500m. These chainages of the inner entrance channel are shown in Appendix D.*

KBR has been provided with survey data from the year 2000 onwards, hence this period will be used to estimate siltation rates. Dredging operations during this time are briefly summarised as follows.

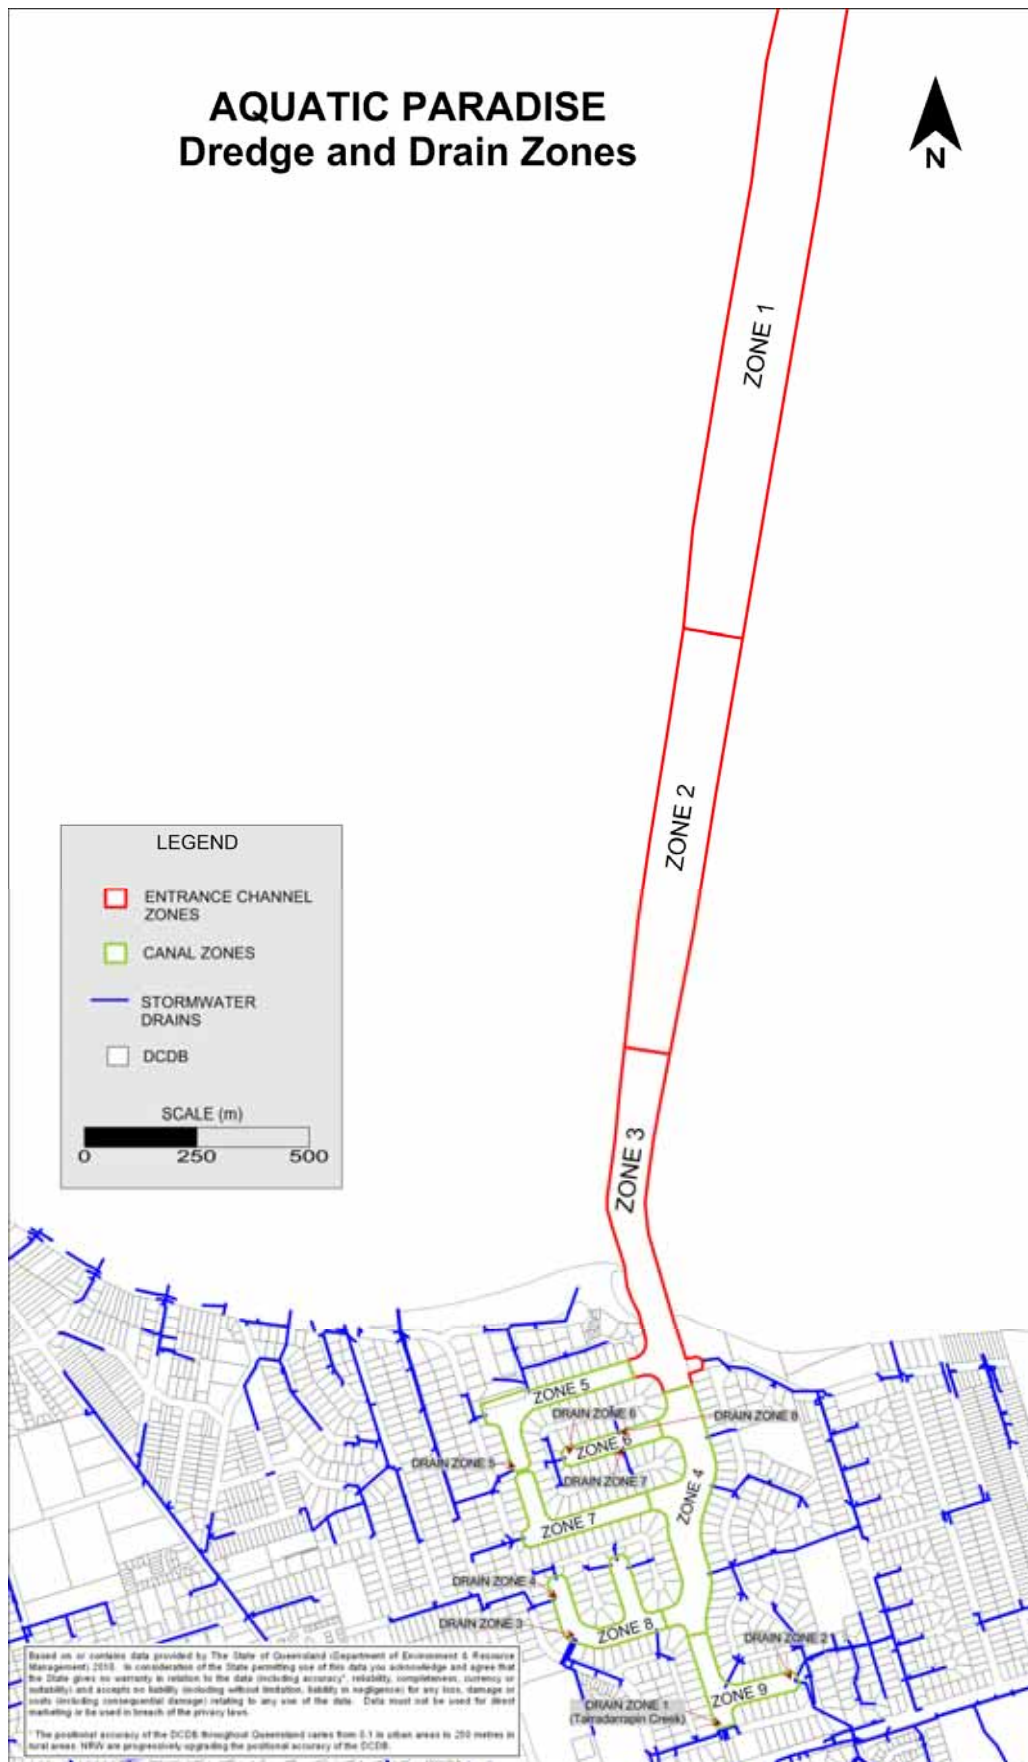
Proposed dredge zones are based on observed siltation patterns; regions exhibiting similar siltation rates are grouped together with the intention that zone specific siltation volumes may be used to inform future dredge campaigns. The dredge zones are shown in Figure 4.1. Zones 1, 2 and 3 make up the entrance channel and Zones 4, 5, 6, 7, 8 and 9 make up the canals.

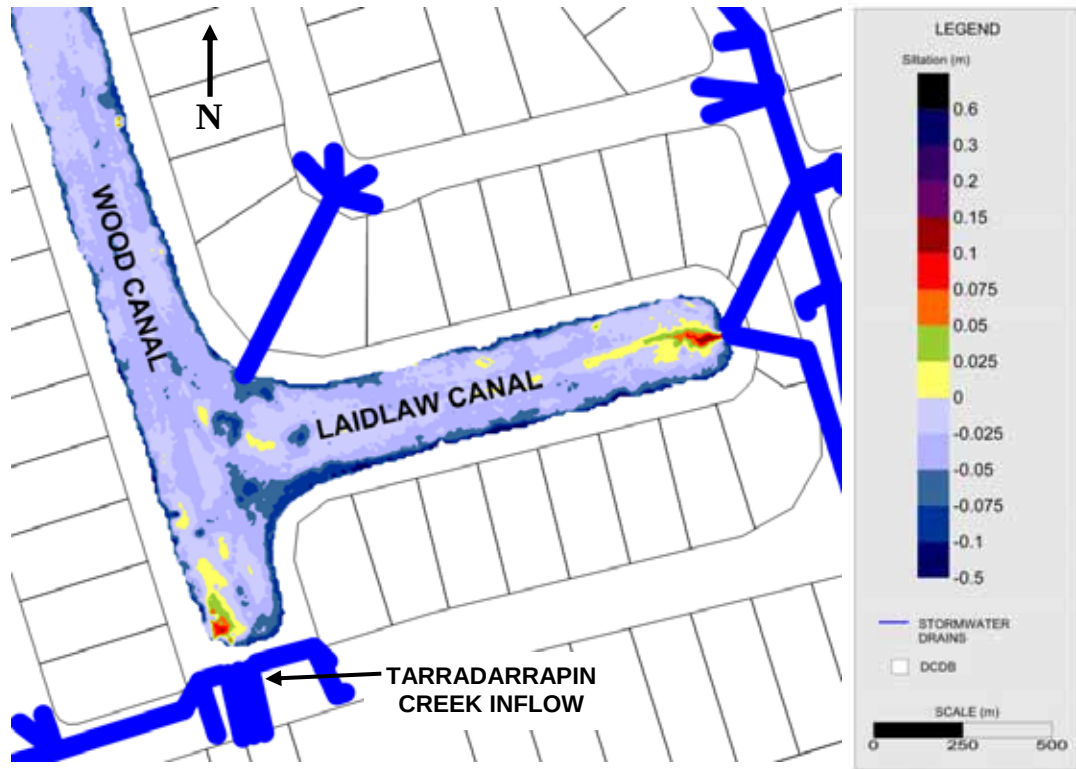
**Figure 5.1**  
**SILTATION MOUNDS (LAIDLAW AND WOOD CANALS)**

The DTMs show isolated mounds of siltation at some locations where stormwater drains flow into the canals. A zoomed image showing a couple of these ‘stormwater drain siltation mounds’ from the 2009 to 2011 annual siltation DTM is shown in Figure 5.1.

Based on the 2000 to 2011 annual siltation DTM, each year approximately 43 m<sup>3</sup> of sediment accumulates in the canals each year as a result of sediment and debris coming from stormwater drains. This represents approximately 0.4% of the total average annual siltation of 10,200 m<sup>3</sup>.

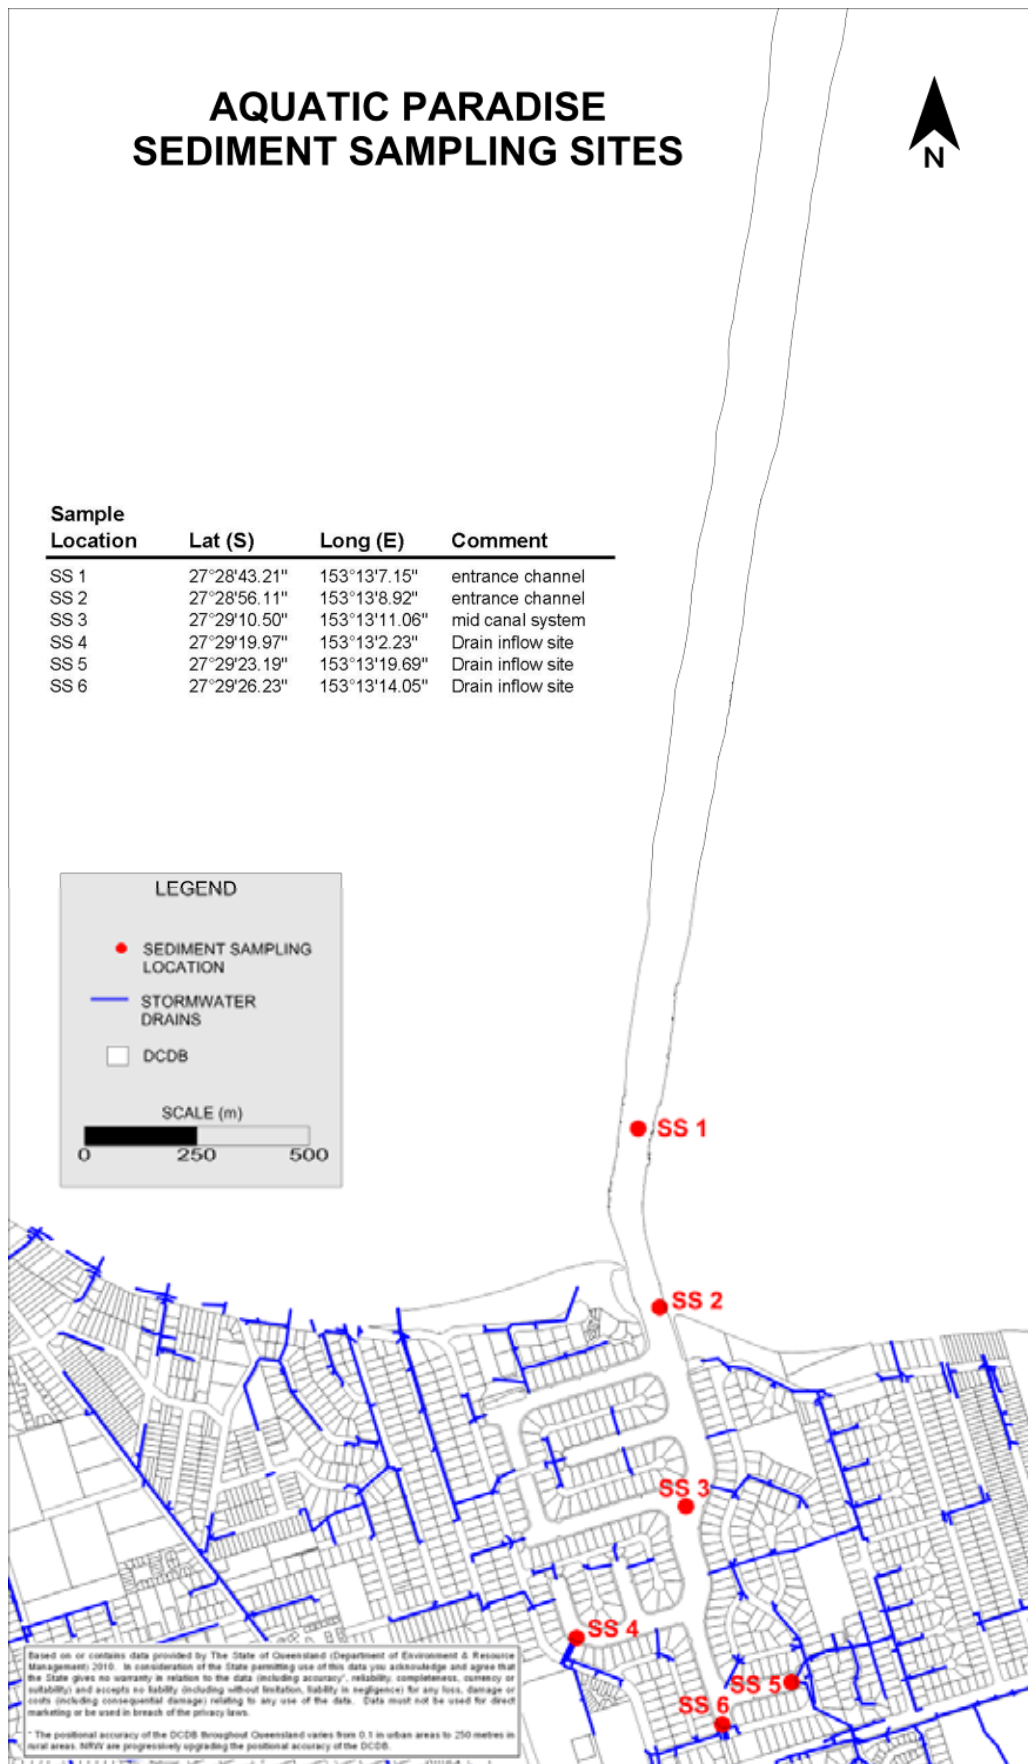
**Figure 6.1**  
**SEDIMENT SAMPLE SITES**

Each sample site was identified using a GPS. Sediment samples were extruded, photographed and some of the sediment was bagged for further inspection. This process was undertaken at six sediment sampling locations within the Aquatic Paradise canal system.

The sediment sampling locations were chosen based on analysis of the hydrographic surveys. These locations were at points of high sedimentation identified in the 2009 to 2011 Annual Siltation DTM. The sediment sampling locations can be seen in Figure 6.1. Sediment sample sites 1, 2 and 3 are at locations of high sedimentation which is expectedly due to sedimentation process from Moreton Bay. Whilst sample sites 4, 5 and 6 are at identified locations of localised sedimentation where stormwater drains enter the canal system.

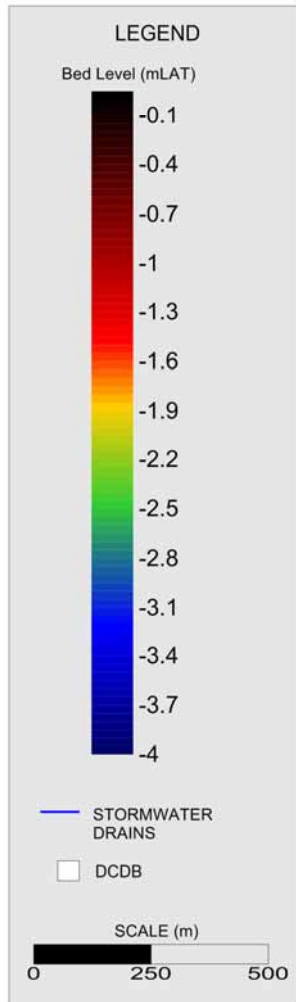
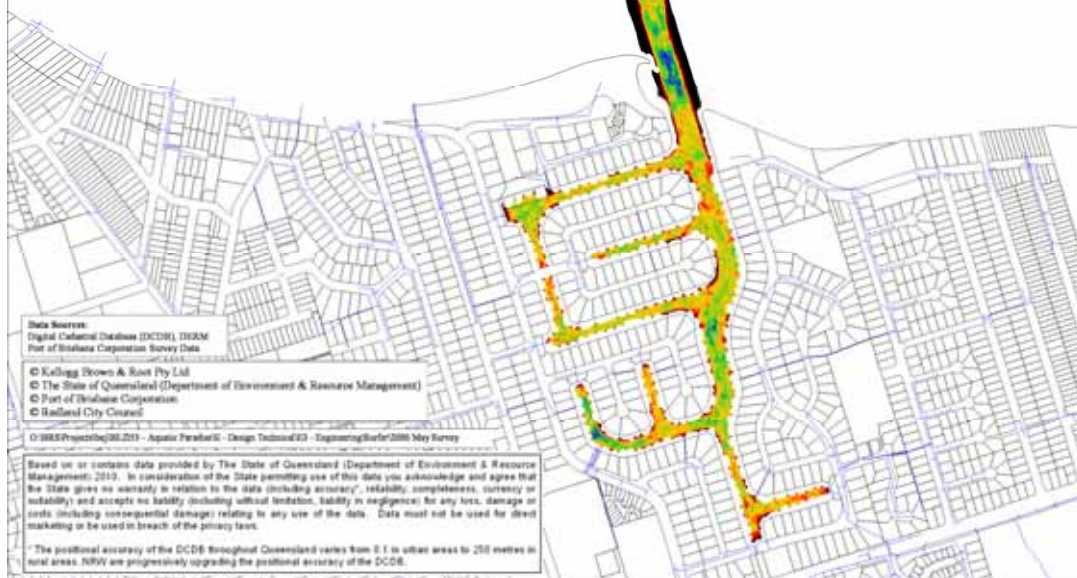
CANALS & ENTRANCE CHANNEL  
May 2000 - Post Dredge Survey (LAT datum)

# AQUATIC PARADISE BED LEVELS

The survey datasets were plotted for a rough check of their validity and verified against survey notes and datum levels. They were then converted from XYZ points to a DTM of the canal using 3D mapping and modelling software. This process facilitates subtraction of surveys to obtain siltation isopachs. The bed level DTMs are provided in Appendix A.

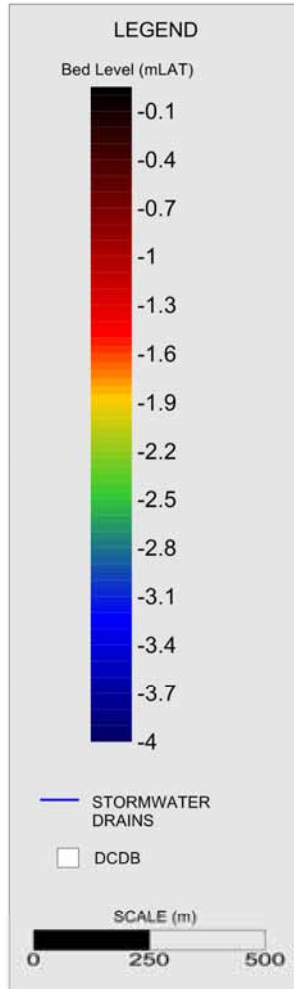
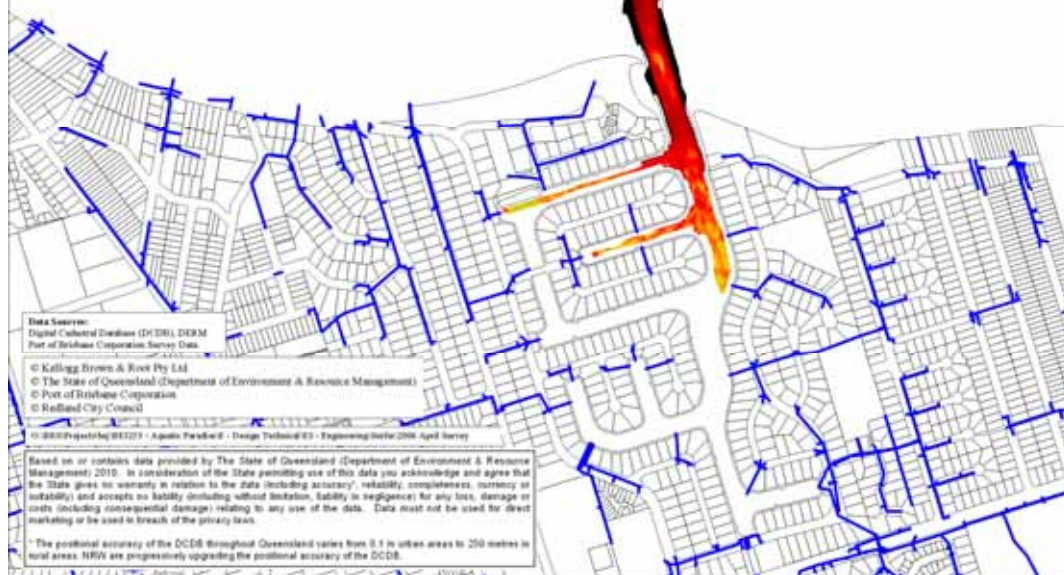
April 2006 - Pre Dredge Survey (LAT datum)

# AQUATIC PARADISE BED LEVELS

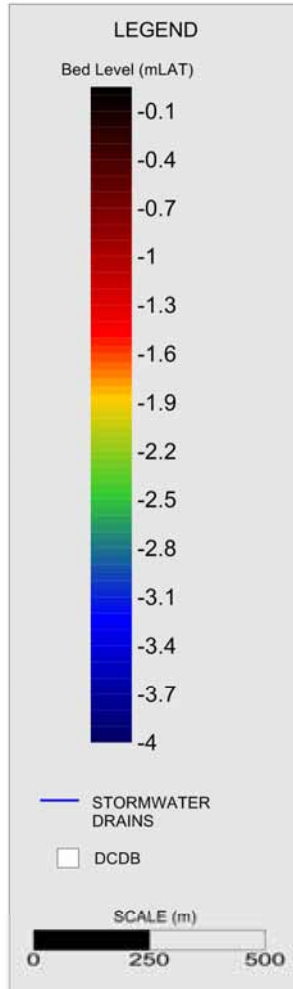
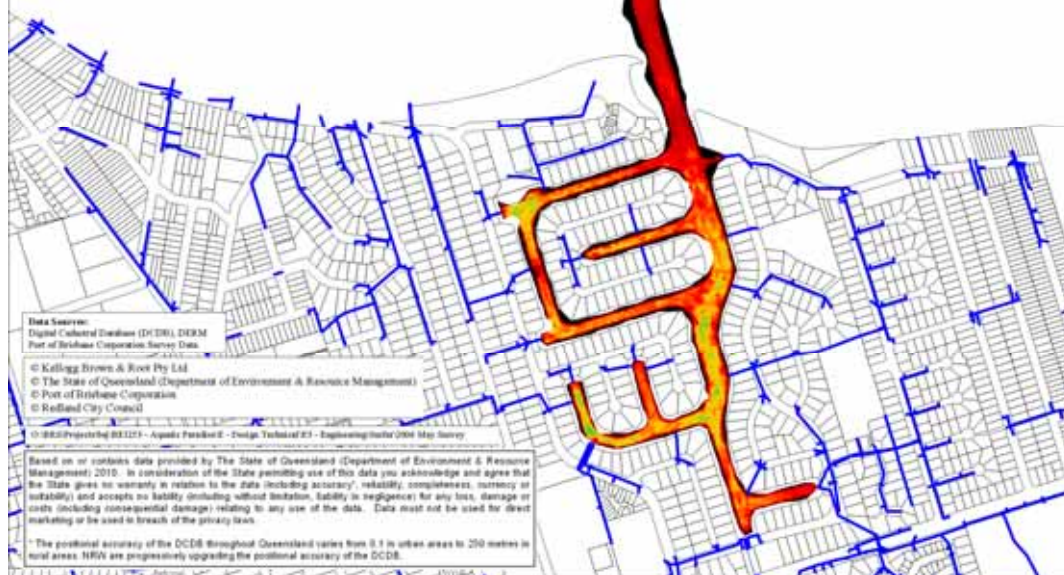
CANALS & ENTRANCE CHANNEL  
May 2006 - Post Dredge Survey (LAT datum)

# AQUATIC PARADISE BED LEVELS

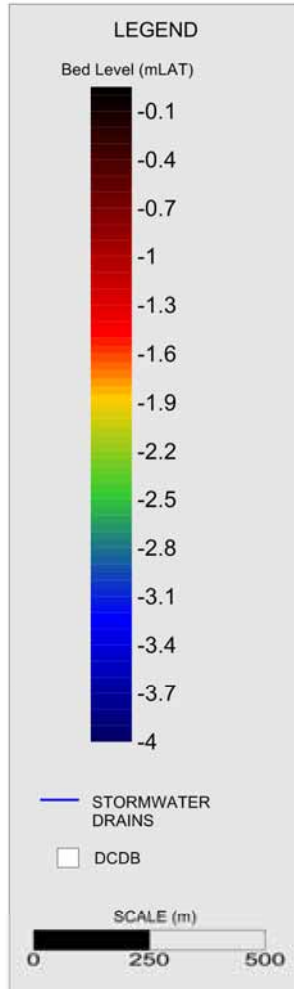
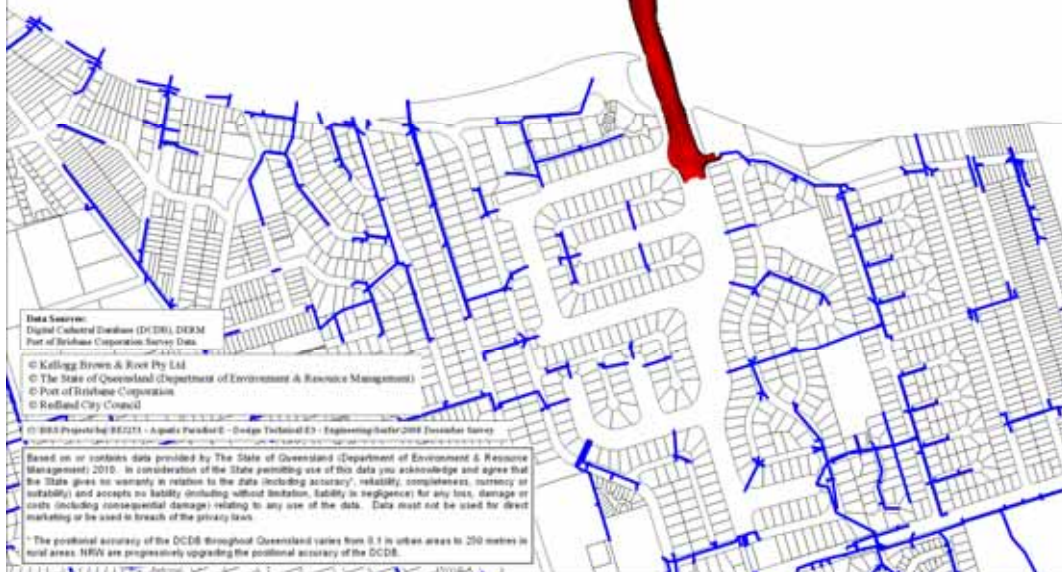
December 2008 - Pre Dredge Survey (LAT datum)

# AQUATIC PARADISE BED LEVELS

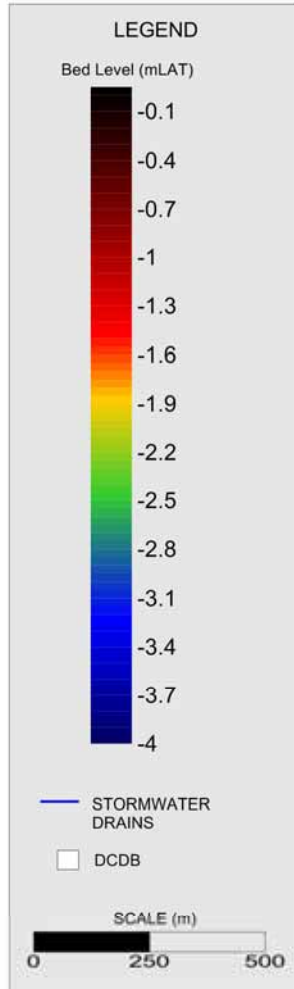
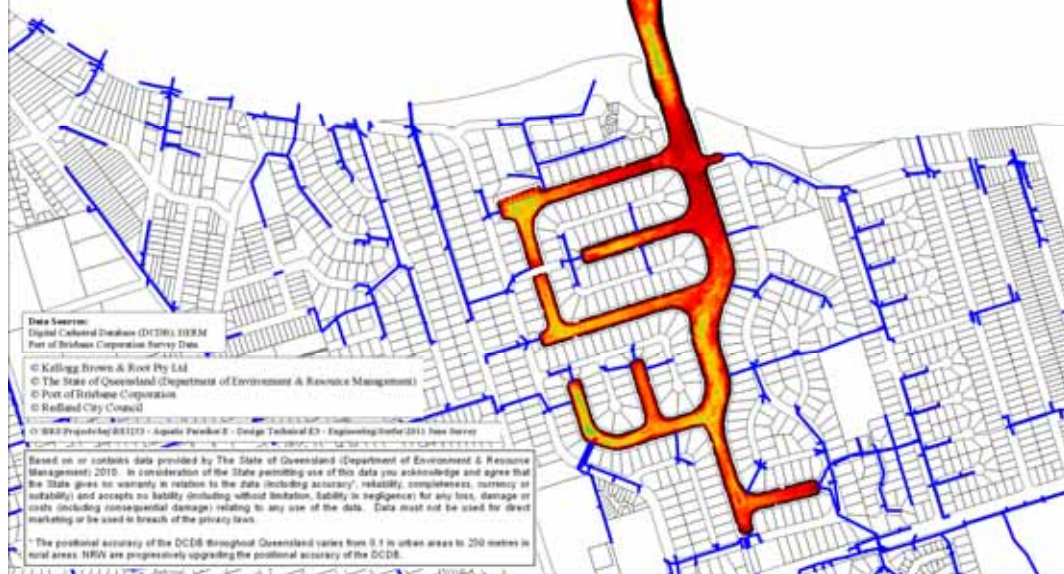
June 2011 - General Survey (LAT datum)

# AQUATIC PARADISE BED LEVELS

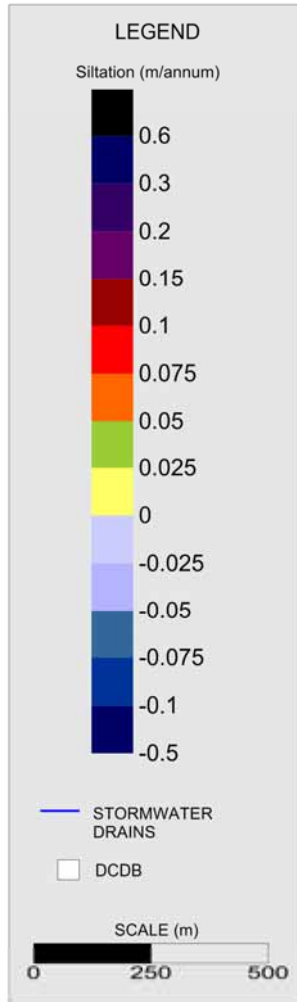
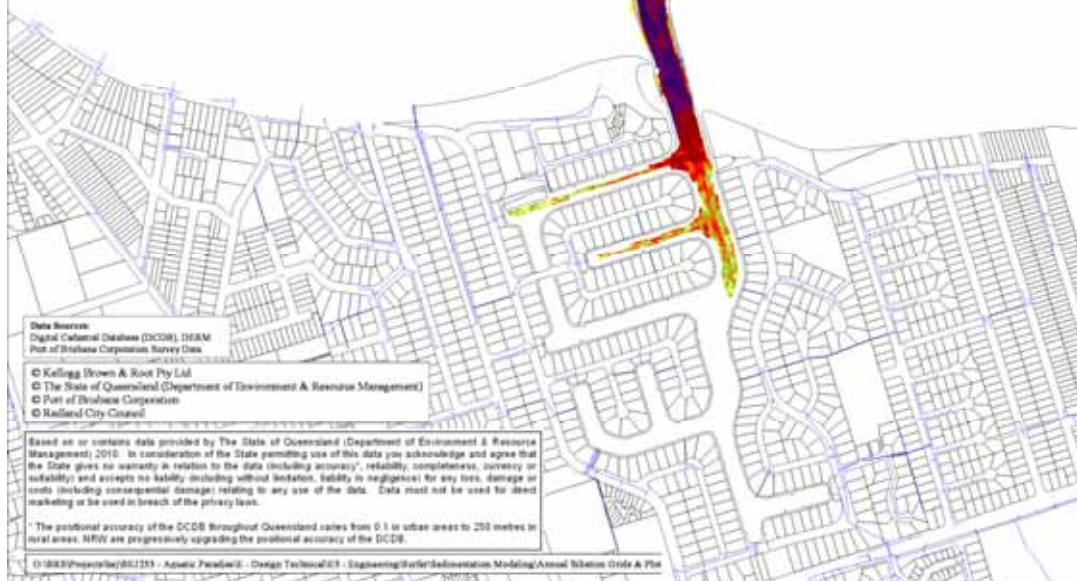
CANALS & ENTRANCE CHANNEL  
between May 2000 & May 2006

# AQUATIC PARADISE ANNUAL SILTATION

- May 2000 to May 2006 (partial extent model\*).
- May 2006 to September 2009 (full extent overlayed model\*).
- September 2009 to June 2011 (full extent model\*).
- May 2000 to June 2011 (full extent model\*).

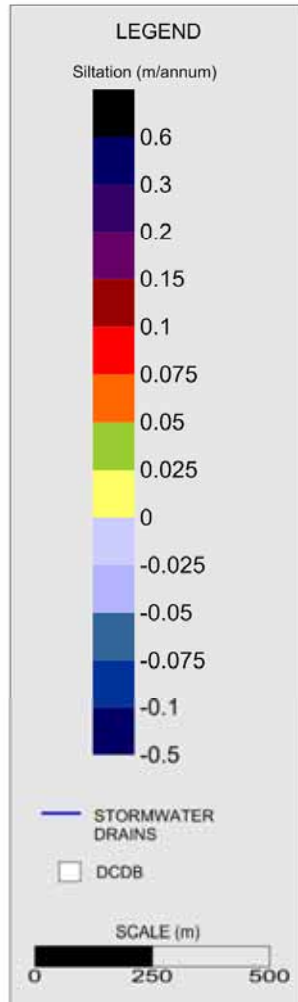
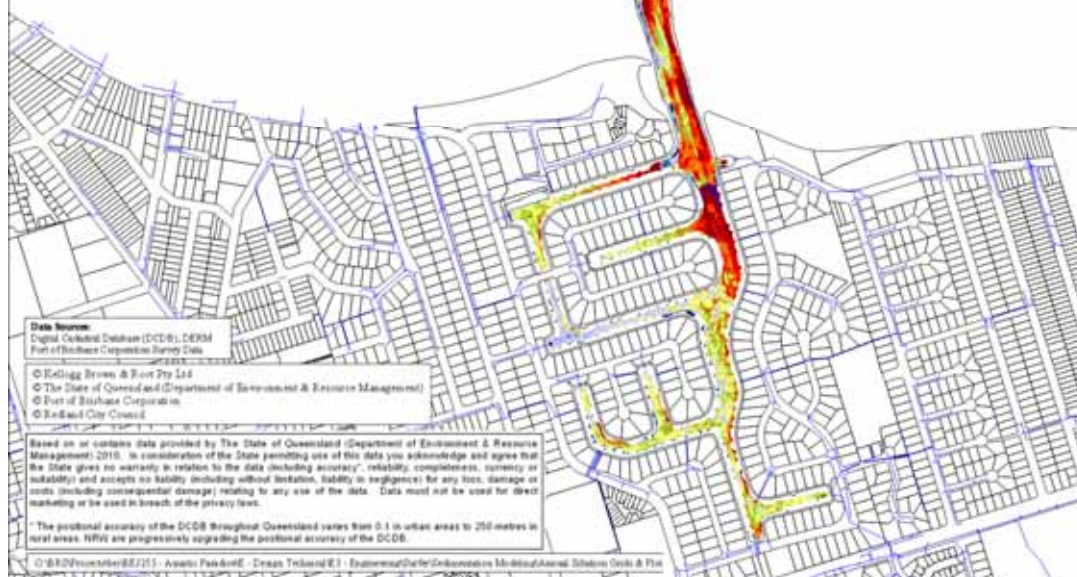
CANALS & ENTRANCE CHANNEL  
between May 2006 & September 2009

# AQUATIC PARADISE ANNUAL SILTATION

When the siltation trap was becoming full between 2006 and 2009, apparently more siltation accumulated throughout the entire canal system. Once the trap was dredged in 2009, then the 2009 to 2011 Annual Siltation DTM indicates less siltation throughout the canal system. The relevant DTMs can be found in Appendices A and B. It appears that a dredged silt trap is quite successful at reducing siltation throughout the canal system. Further investigations could also be undertaken to show potential benefits of dredging the siltation trap deeper than current design levels, and/or beam dragging sedimentation into the trap.

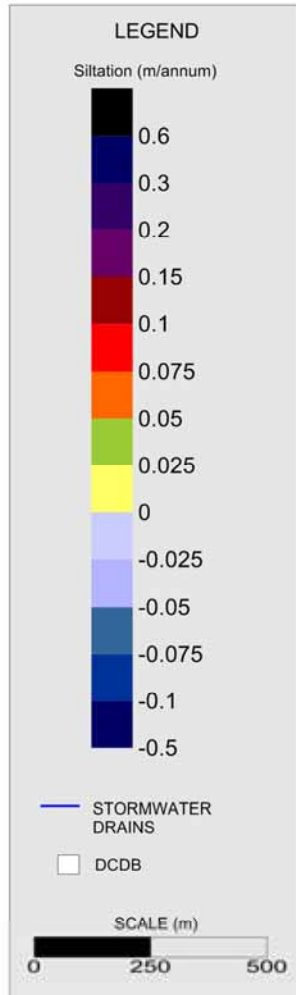
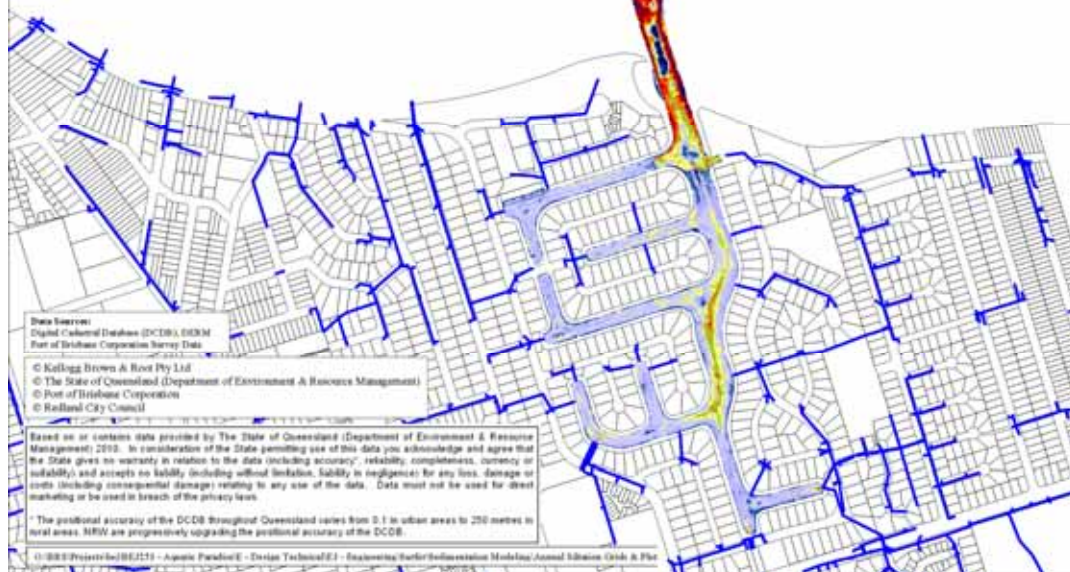
CANALS & ENTRANCE CHANNEL  
between September 2009 & June 2011

# AQUATIC PARADISE ANNUAL SILTATION

- Over the 2000 to 2011 period the greatest rate of annual siltation accumulation is in the siltation trap and inner entrance channel.
- Much lower observed canal siltation after the Zone 3 ‘silt trap’ had been dredged (e.g. 2009–2011).

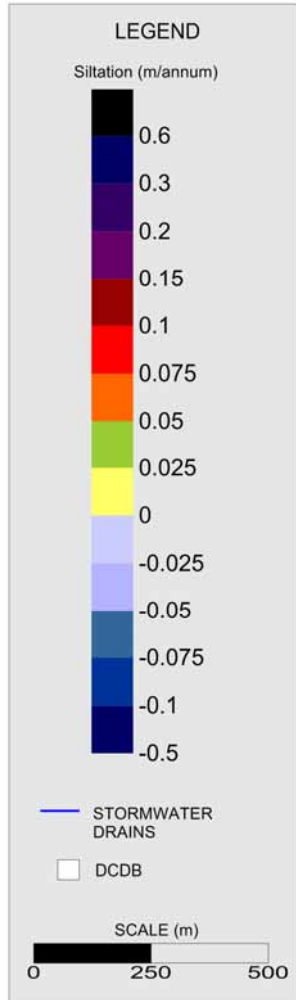
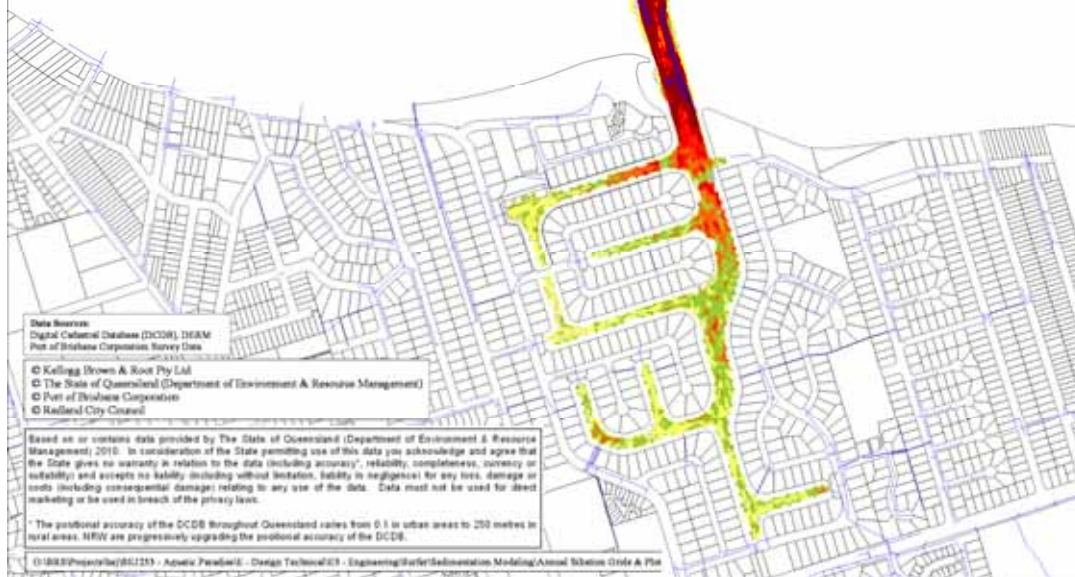
CANALS & ENTRANCE CHANNEL  
between May 2000 & June 2011

# AQUATIC PARADISE ANNUAL SILTATION

KBR recommends that the 2000 to 2011 survey period is the most useful for analysing siltation patterns and identifying siltation sources and volumes. This is primarily due to its greater coverage and being over the longest time period, hence producing the most reliable long term siltation pattern estimate. The three other siltation periods (which fall in the 2000 to 2011 period) are still useful in assessing siltation patterns and origins in and between their respective time steps, however partial survey coverage, potential survey inaccuracies and shorter time frames means they were not adopted for KBR's assessment of siltation rates and volumes.

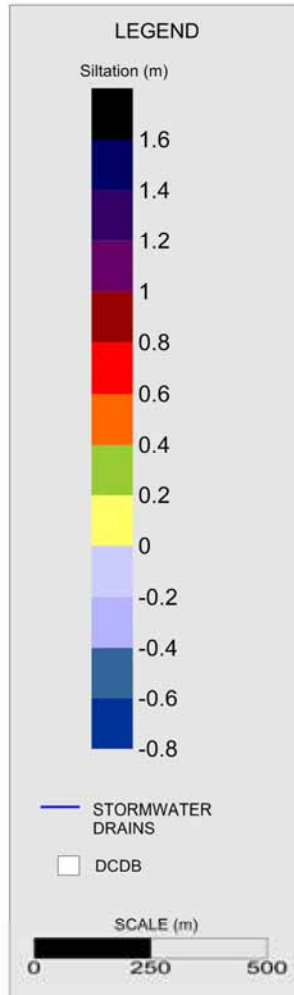
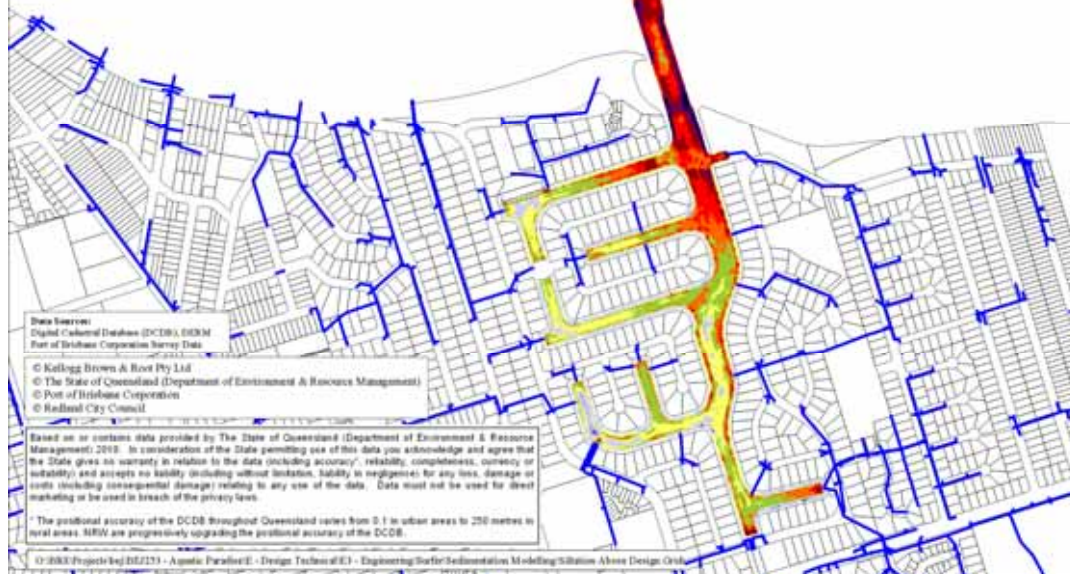
# AQUATIC PARADISE SILTATION ABOVE DESIGN LEVELS CANALS & ENTRANCE CHANNEL between Design Bed Levels & June 2011

- Annual siltation rate (for a particular period) = newer survey minus older survey; then divided by the time (in years) between the two surveys.
- Current accumulated siltation above design levels = most current survey minus canal design levels.

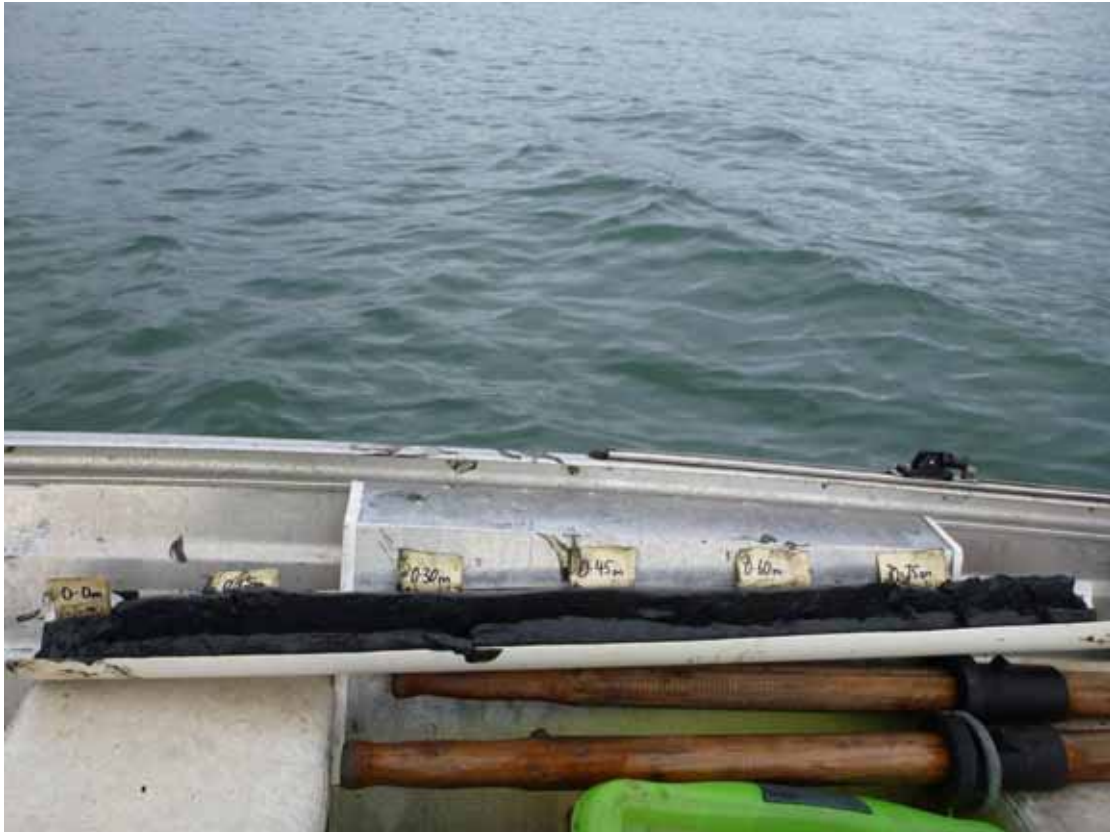
**Figure 1**  
**SS 1 TOTAL CORE (0–0.9m)**

Aquatic Paradise Canals – 1 June 2012  
Piston sampling
